Subject: POOR A/C PERFORMANCE	Bulletin No: 07-004/15
	Last Issued: 09/29/2015

2016 MX-5 vehicles with VINs lower than JM1ND*****103904 (produced before July 29, 2015)

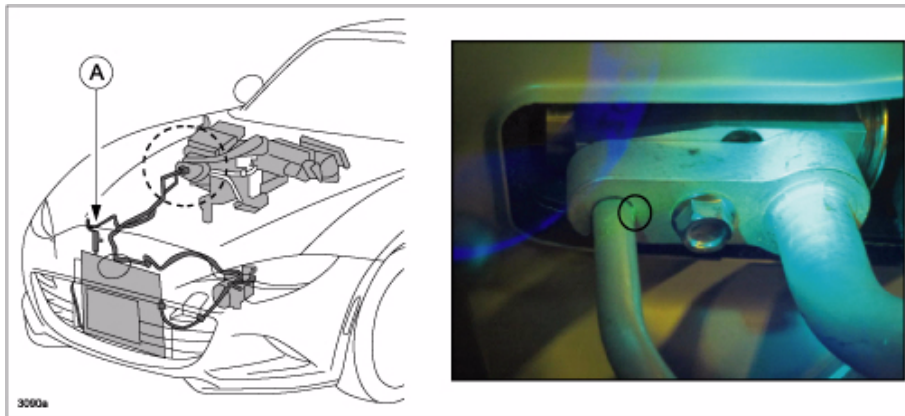
Some vehicles may experience poor A/C performance due to a slow refrigerant leak from the O-ring groove on the cooler pipe (high pressure side) at the expansion valve.

1. Verify customer concern.
2. Using a refrigerant leak detector or a black light, determine where the leakage is coming from.
 - If the leak is detected at the connection where the “Cooler Pipe (HI) C” connects to the expansion valve, replace the “Cooler Pipe (HI) C” (A) with a new one according to the instructions on MS3 online or the Workshop Manual (section 07-11 REFRIGERANT LINE REMOVAL/INSTALLATION).
