Subject: GROAN NOISE FROM FRONT WHEEL HUB	Bulletin No: 03-006/15
	Last Issued: 09/29/2015

BULLETIN NOTE

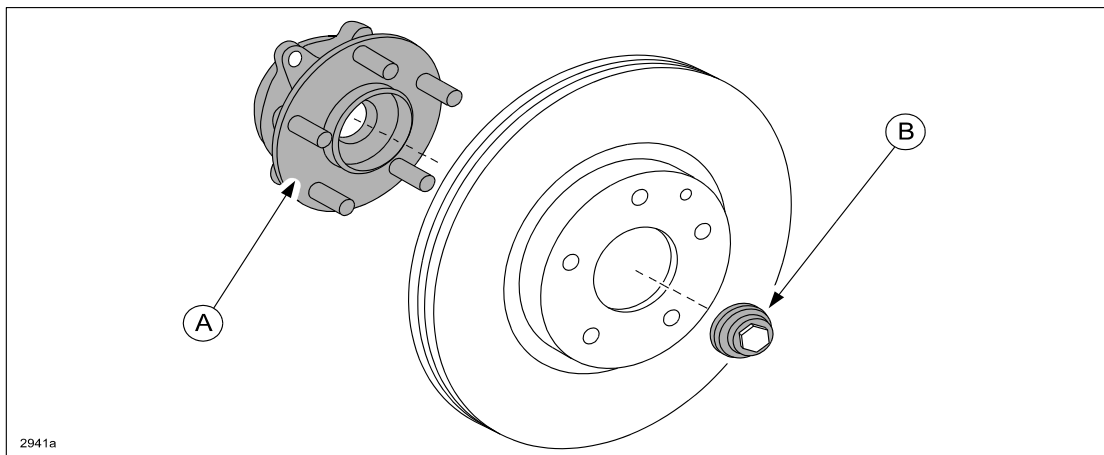
Some vehicles may exhibit a groan type noise from the front wheel hub bearing while driving at high speed or when cornering. This may be caused by front wheel hub bearing corrosion.

1. Verify customer concern.
2. Replace the affected front wheel hub (A) and locknut (B). Refer to MS3 online or Workshop Manual (section 03-12) removal/installation instructions for the front wheel hub and the locknut only.
 - CX-5 - WHEEL HUB COMPONENT REMOVAL/INSTALLATION [AWD]
 - Mazda6 - WHEEL HUB, STEERING KNUCKLE REMOVAL/INSTALLATION
