© 2015 Mazda Motor of America, Inc.

Subject: DOORS DO NOT LOCK / UNLOCK WHEN USING DOOR REQUEST SWITCH	Bulletin No: 09-038/15
	Last Issued: 09/22/2015

2007-2015 CX-9 vehicles equipped with advanced keyless entry system

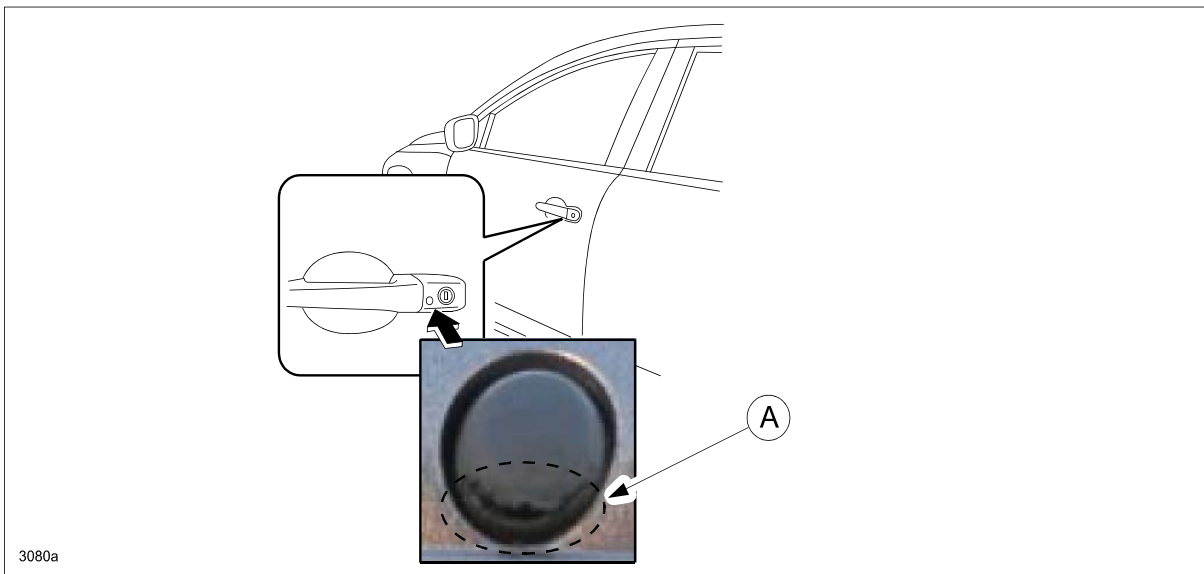
Some customers may complain that the doors do not lock / unlock when pressing the request switch. This may be caused by a torn or cracked request switch rubber button (A).

The rubber surface of the request switch may become gradually worn out by repeated use. Water may enter the request switch and cause a short-circuit of the electrical system.

To eliminate this concern, the thickness of the rubber button has been increased from 0.6 mm to 1.8 mm to improve wear resistance.
