Service Bulletin

Subject:	t: SQUEAKING/GRINDING NOISE FROM REAR BRAKE	Bulletin No:	04-003/15
		Last Issued:	09/16/2015

2014-16 Mazda3 vehicles with VINs starting with JM1

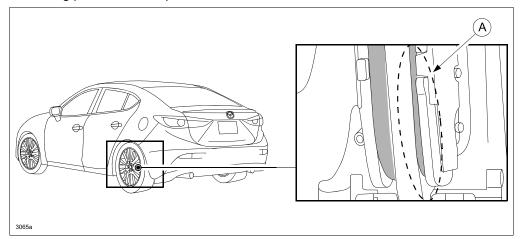
Some vehicles may experience a squeaking/grinding noise from the rear brake even after the brake pedal is released. Upon inspection, the caliper mounting support is corroded and the disc pad is abnormally worn out (A). This is caused by vehicle usage in an area using road salt. The surface of the mounting support may swell from corrosion causing premature disc pad wear and brake noise.

To correct the problem, an improved caliper mounting support has been newly established as a service part. The anti-corrosion surface treatment has been changed from Zn to Zn-Ni plating.

- 1. Verify that the caliper mounting support(s) is corroded and the disc pad(s) is abnormally worn out.
- Replace the caliper mounting supports (both sides) with the modified service parts sets and attachments with new parts according to the instructions on MS3 online or the Workshop Manual (section 04-11 REAR BRAKE (DISC) REMOVAL/INSTALLATION).

NOTE: Replace the disc plate(s) additionally if damaged by the completely worn out disc pad.
