<b>Subject:</b>  FRONT SCUFF PLATE COMES OFF TOO EASILY	<b>Bulletin No:</b> 09-035/15
	<b>Last Issued:</b> 09/03/2015

2016 MX-5 with VINS lower than JM1ND\*\*\*\*\*101879 (produced before June 11, 2015)

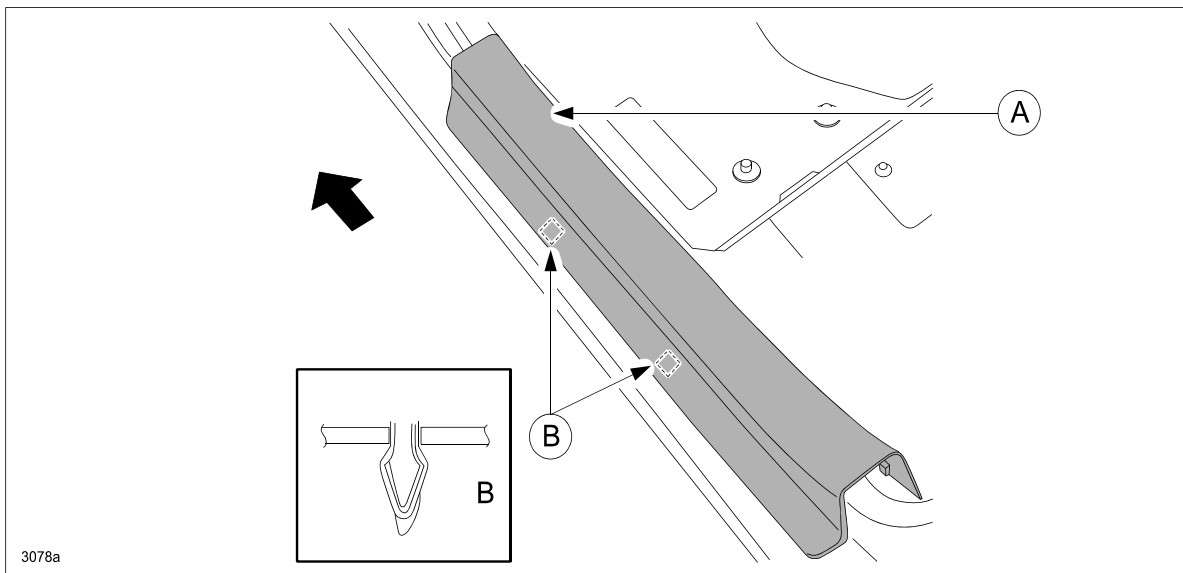
On some vehicles, the right and/or left side front scuff plate (A) may come off too easily with little force, such as when wiping it with cloth or removing the protective cover on it. The retaining force of the scuff plate clips (B) may be insufficient. To correct the problem, the shape of the scuff plate clips has been changed to increase the retaining force.

1. Verify customer concern.
2. Replace the affected side scuff plate(s) with the modified one(s) according to the instructions on MS3 online or the Workshop Manual (section 09-17 SCUFF PLATE REMOVAL/INSTALLATION).
3. Verify repair.
