Subject: Eaton FR Transmission

Models Affected: Specific Freightliner Cascadia, Business Class M2, 108SD, and 114SD vehicles and Western Star 4700 vehicles manufactured January 4, 2015, through April 24, 2015, with certain Eaton FR 10-speed manual transmissions.

November 2015
FL693A
NHTSA #15V-617

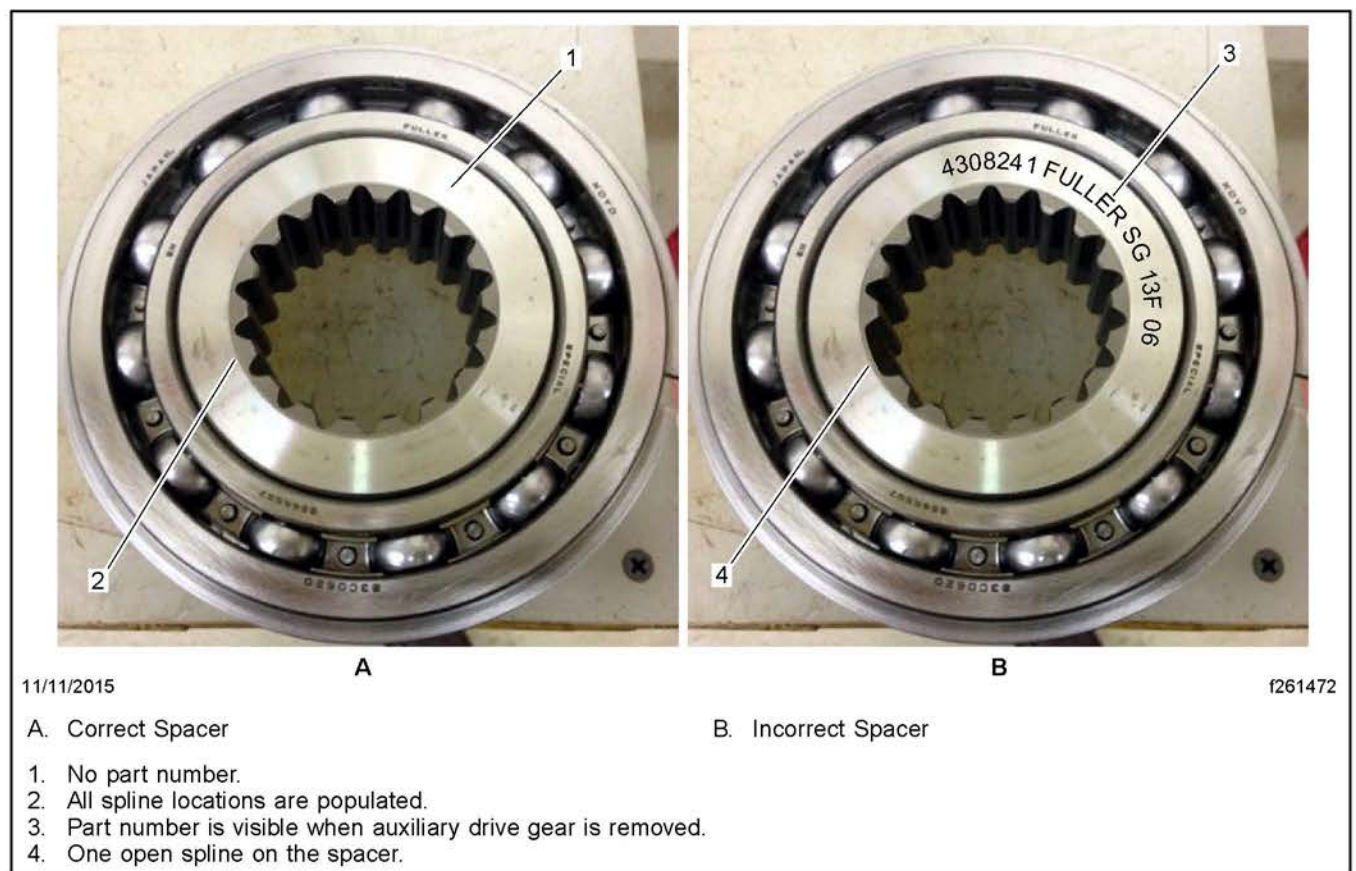
Fig. 1, Spacer Identification

The correct spacer does not have an open spline or a visible part number printed on it. **Fig. 1**, Ref A shows the correct spacer, and Ref B shows the incorrect spacer. Submit photographs to RTW for verification regardless of the spacer installed.

If the spacer has all the possible splines engaged with the mainshaft and no visible part number, go to step 20.

If the spacer has an open spline and the part number 4308241 is visible, go to step 19.

19. Work with RTW to perform a detailed inspection of the main transmission components for damage. If damage is found, remove the transmission; see "Transmission Removal and Installation" in these work instructions.
20. Move the shift bar housing from the top of the transmission.
21. Install the auxiliary drive gear and snap ring.
22. Clean the sealing surfaces of the main case, shift bar housing, auxiliary section, and shift tower.
23. Set a new shift bar housing gasket in place.
24. Position the shift bar housing, using a spacer block to allow the auxiliary section to be installed.
25. Install the auxiliary section. Tighten the capscrews 40 to 45 lbf-ft (54 to 61 N-m).
