TECHNICAL BULLETIN  
LTB00704NAS1  
05 JAN 2015

**SECTION: 211-02**

Hydraulic Power Steering System Diagnosis

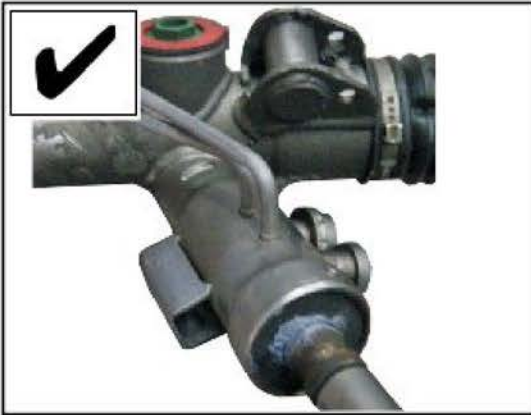
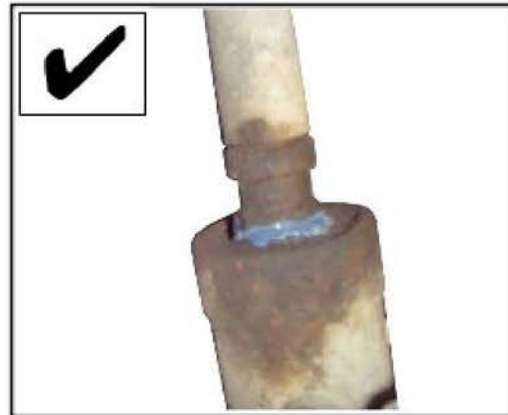
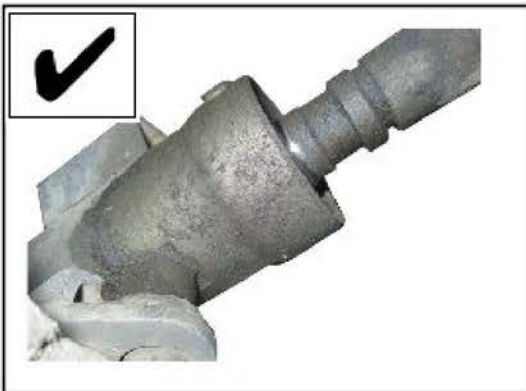
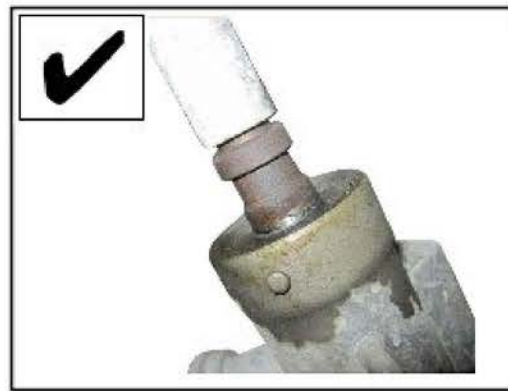
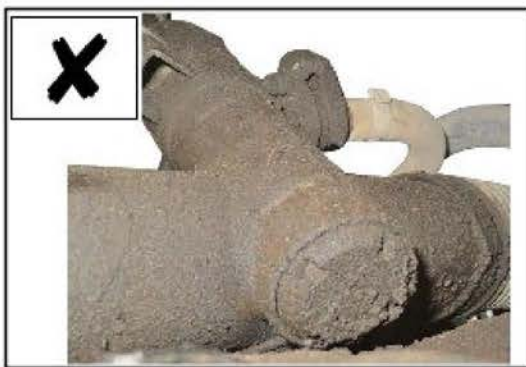
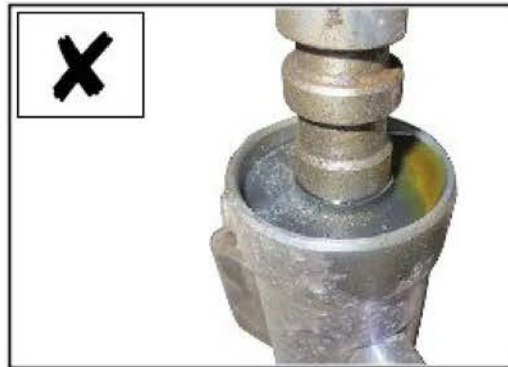
E170144

**NOTE: misting / dampness around the input shaft seal can be mis-diagnosed as leaks (see top four pictures with '✓'); this is normal. Suspected leaks ('X') should always be verified by cleaning and chalking.**

- 'Misting' or a damp area may be commonly seen around the steering gear pinion tower seal and the steering gear bellows. This is normal and occurs on most hydraulic dynamic seals due to their design and is not a reason to change the steering gear, nor does it indicate the part will fail early or later in life. If there is a suspicion of a leak, then normal procedures using cleaning and chalk should be employed.
