<b>Reference</b>	SSM49497
<b>Models</b>	Range Rover Sport / L320
<b>Title</b>	Incorrect Replacement Of The Steering Gear Due to Leaks.
<b>Category</b>	Chassis
<b>Last modified</b>	05-Jan-2015 00:00:00
<b>Symptom</b>	303000 Steering/Handling
<b>Attachments</b>	Wagner valve 1.JPG Wagner valve 2.JPG

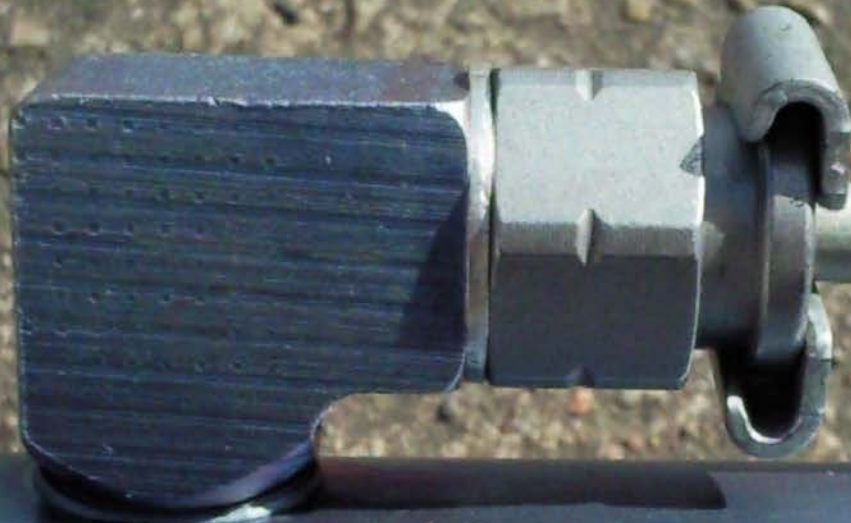
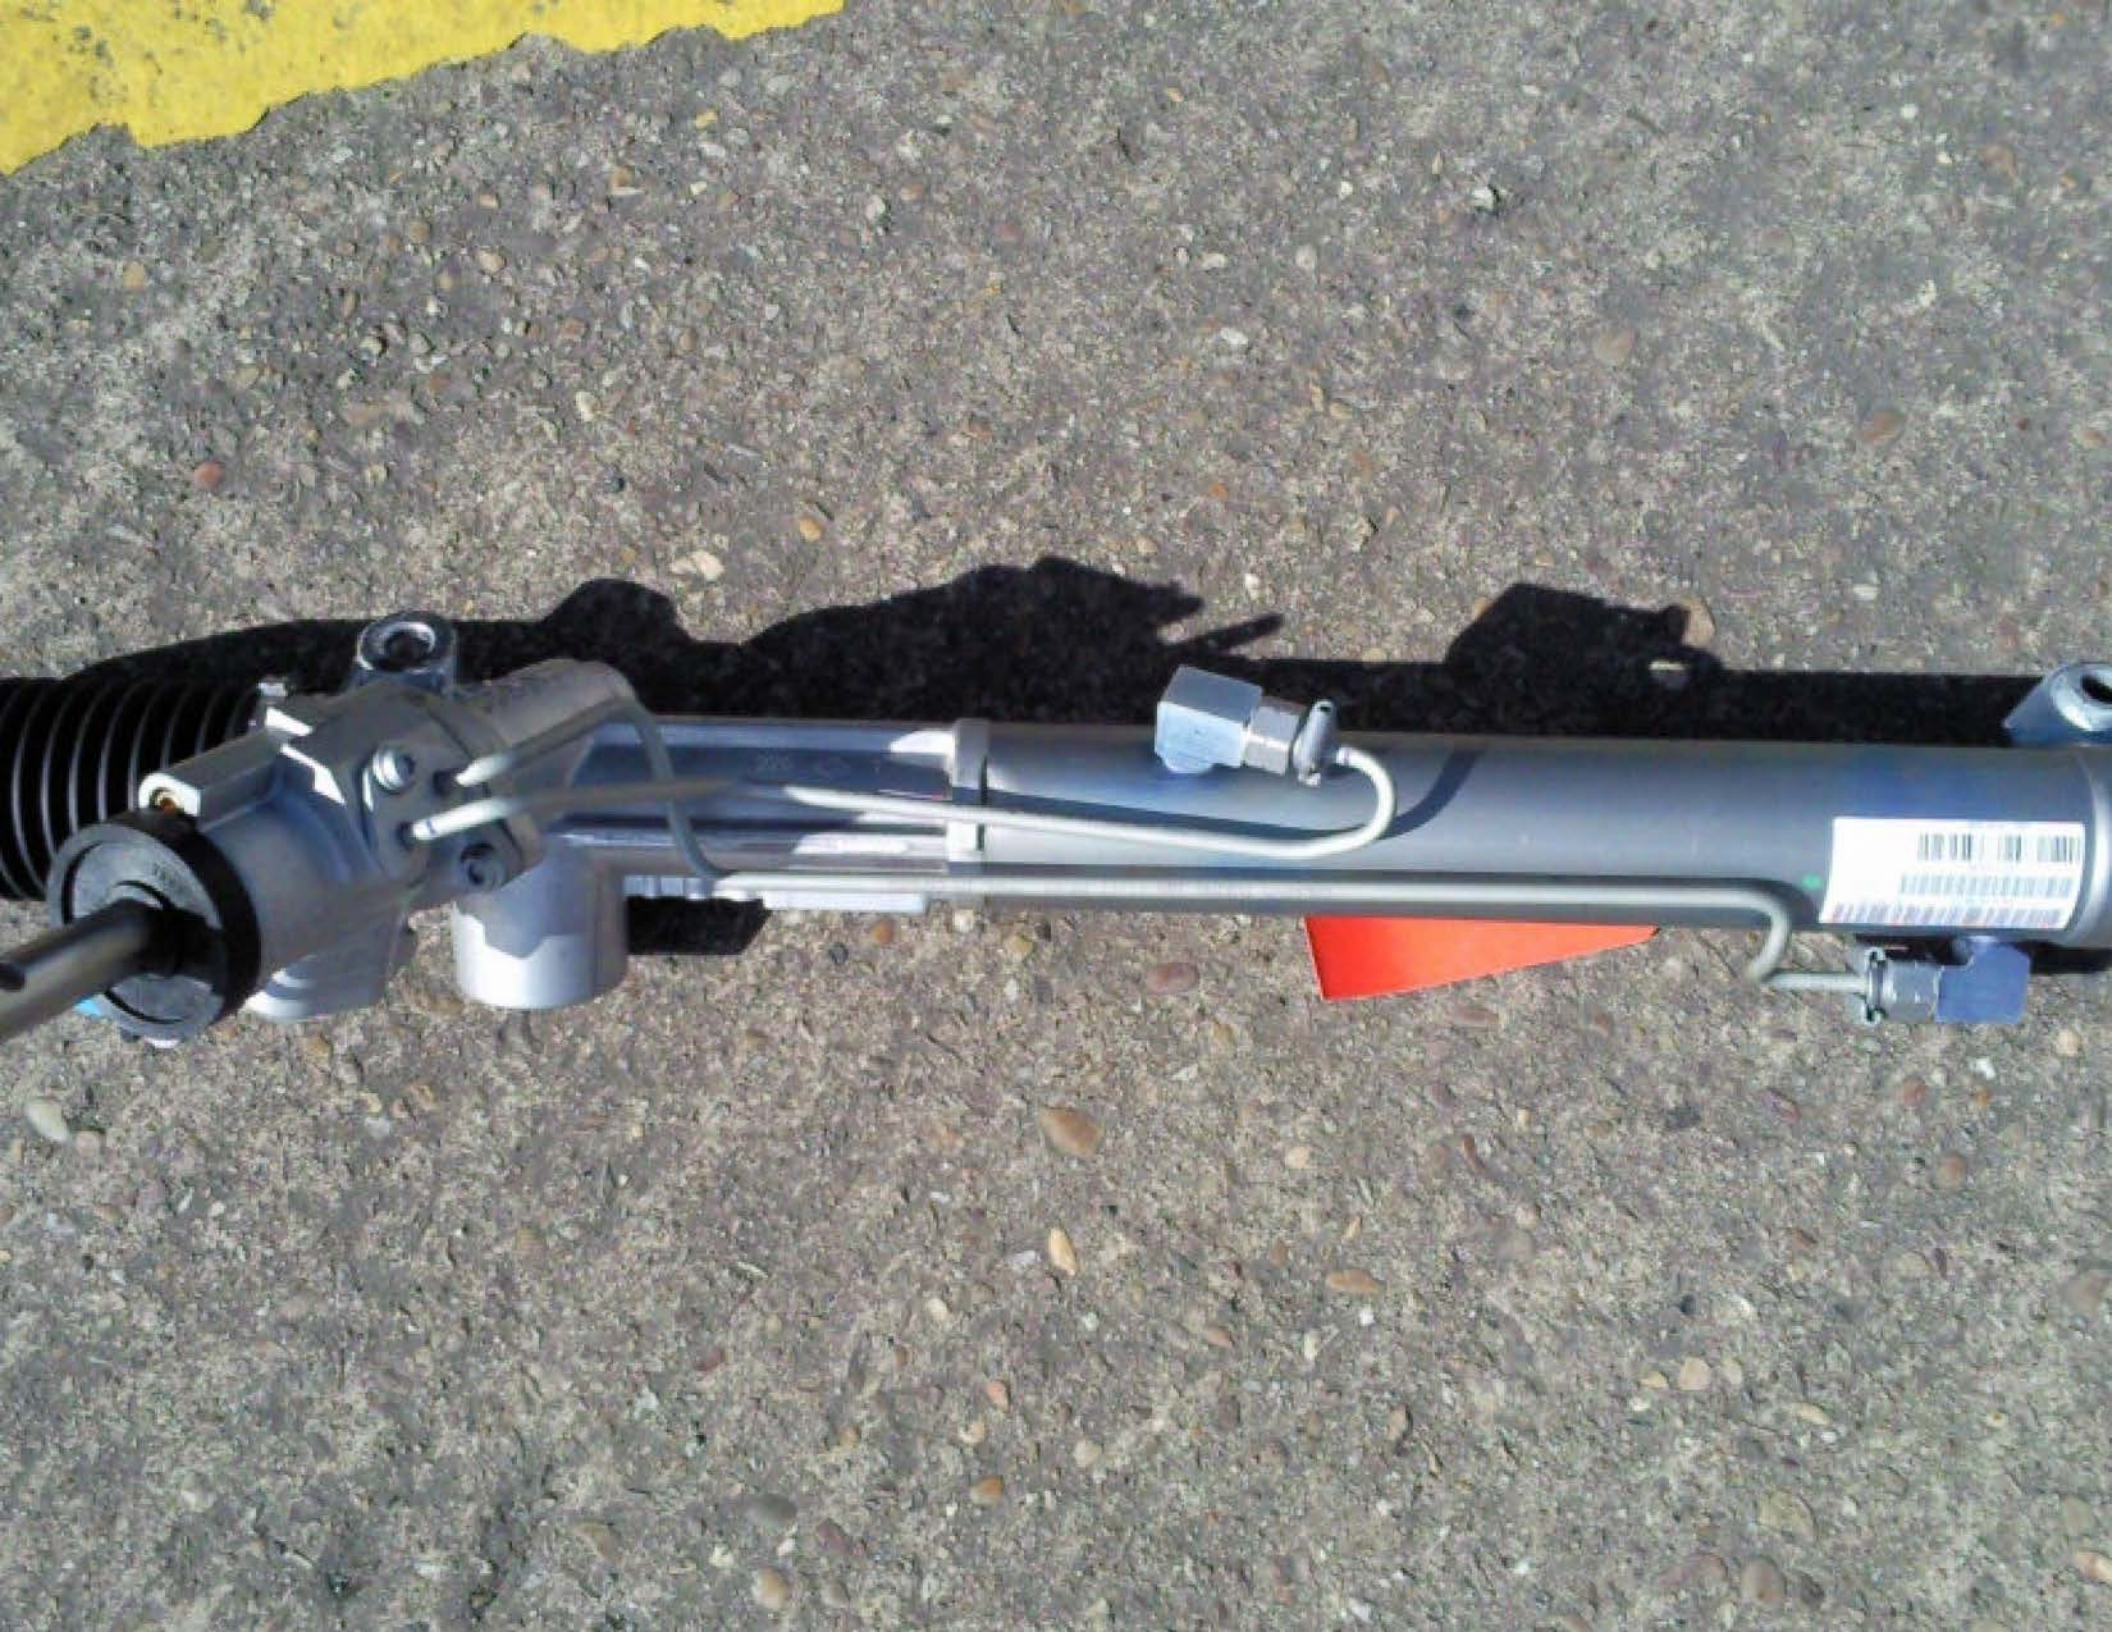
An oil leak may be detected from the steering gear and incorrectly diagnosed as needing a replacement steering gear assembly.

Leak from the Wagner/Steering gear damping valve or sealing washer (see attached photo's)

Before replacing any components, please check that the leak is not from this valve. If the leak is found to be the valve or its joints, replace using QFW500030 and claim service repair time 57.15.89/35 - 1.5 hrs.

More information regarding the replacement service procedure of these valves can be found in TSB LTB00021. TOPIx will be updated to include this replacement procedure in due course.
