<b>Reference</b>	SSM71893
<b>Models</b>	LR4 / L319 Range Rover / L322 Range Rover Sport / L320
<b>Title</b>	AJ133 chain tensioner repair - bulletin LTB00474 version 2
<b>Category</b>	Engine
<b>Last modified</b>	05-Jan-2015 00:00:00
<b>Symptom</b>	497000 Engine Noise
<b>Attachments</b>	blade.pdf

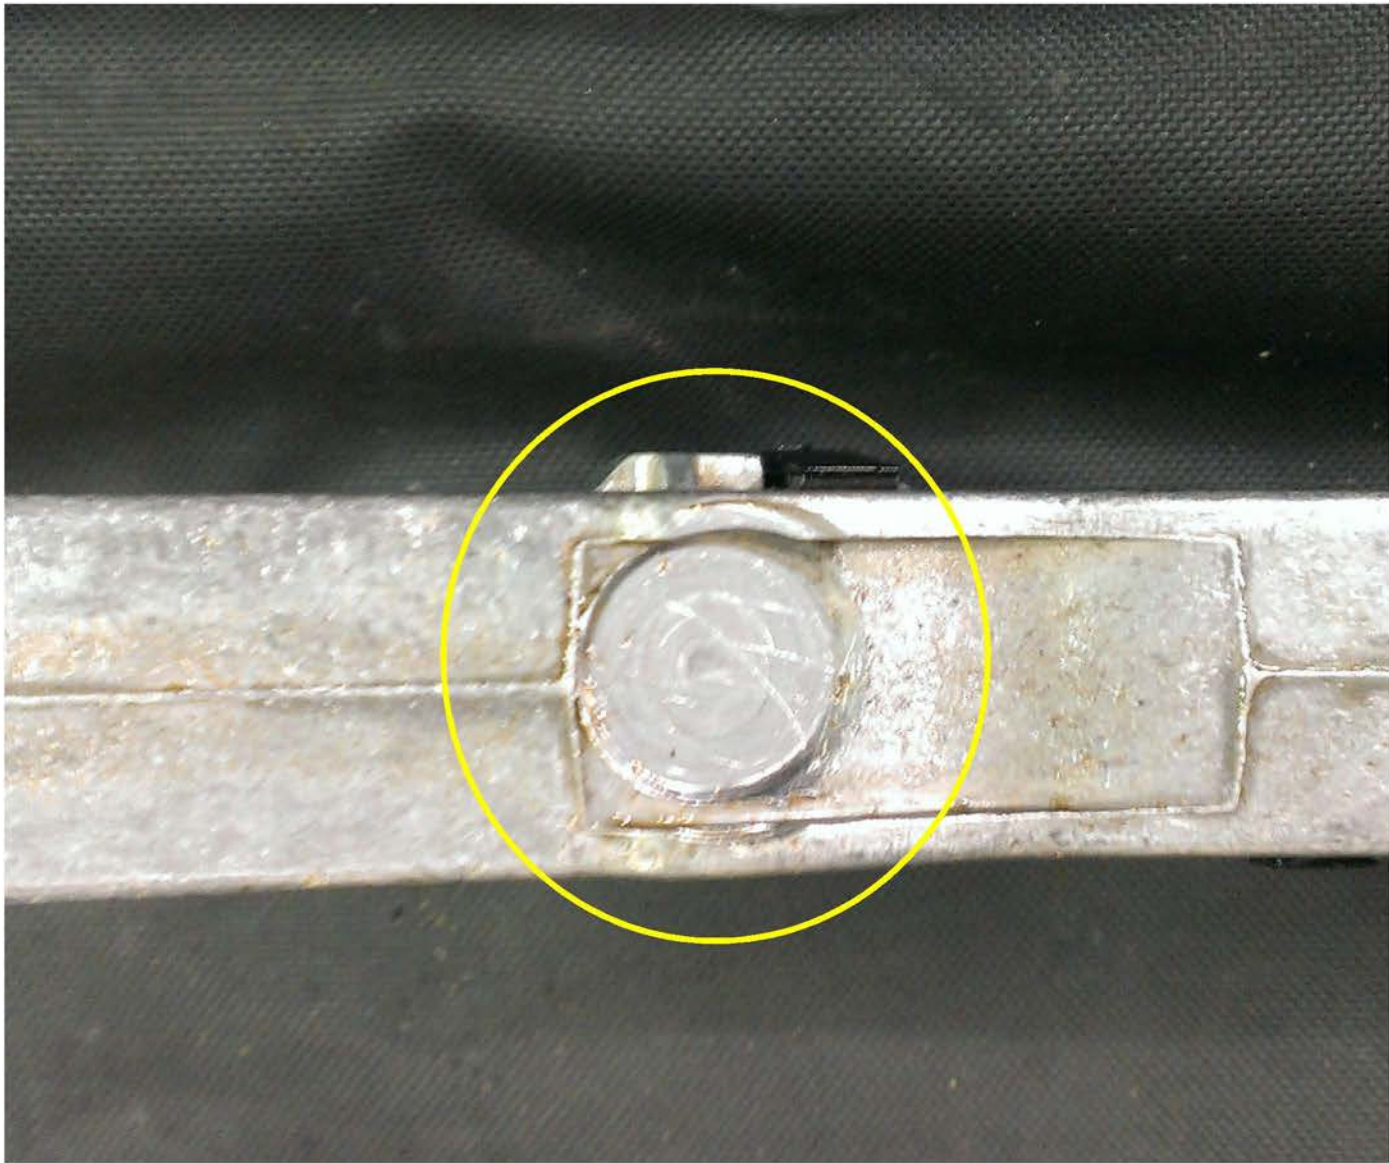
**Cause:** The timing chain was not at the correct tension. This was caused by the full repair procedure in TSB LTB00474 not being followed - a complete set of timing chain tensioners and blades were not fitted.

**Action:** Follow TSB LTB00474 version 2 and replace both pairs of tensioners and blades using the part numbers listed in the technical bulletin. The tensioner blades now have a steel insert to help prevent wear. The design of the tensioner has also changed to match the revised blades. An engine must not have a mix of old level and new level parts fitted. For reference, a picture is attached showing typical wear of the old design tensioner blade, without the steel insert.
