# SAFETY RECALL BULLETIN

November 2015  
15R-2 (FL-691)  
NHTSA #15V-613  
Transport Canada #15-485

Subject: **Detroit Axle Steering Arm Capscrew Inspection**

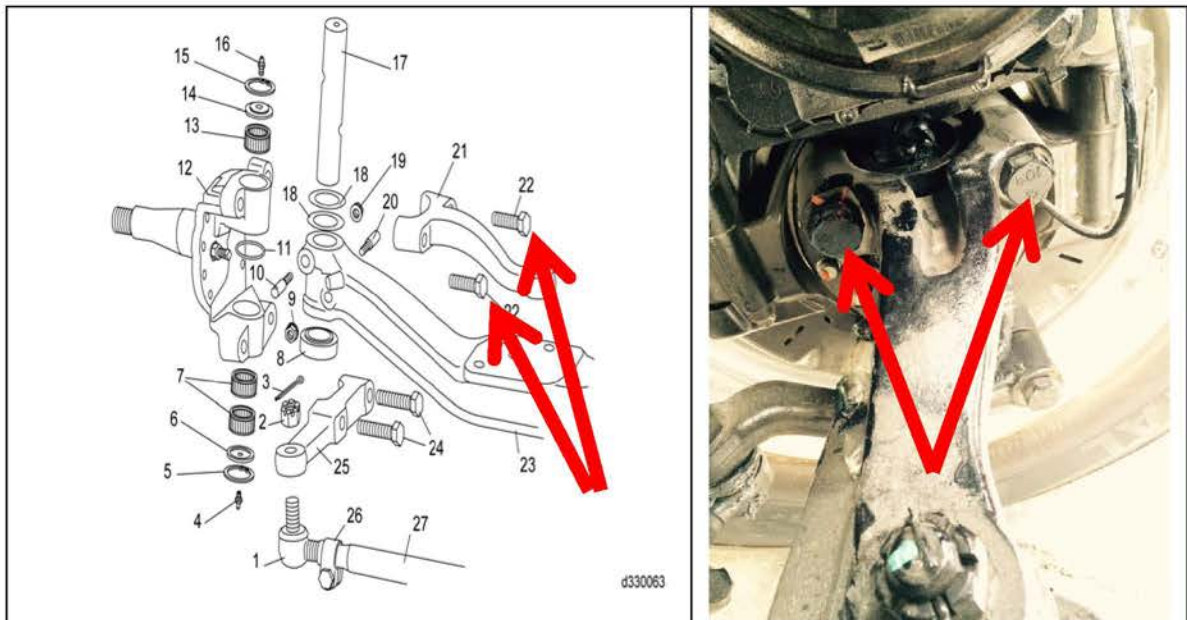
**Figure 1 – Steering Arm Capscrew Location**

2. Apply the parking brake, turn off the ignition, chock the rear wheels, disconnect the batteries, and perform any other applicable safety steps.
3. Using a suitable torque wrench, check the torque on the two steering arm capscrews. See Figure 1.
  - a. For Model 2 and Model 3 axles with a M20 capscrew, correct torque is 425 lbf-ft (575 Nm).
  - b. For Model 5 axles with a M24 capscrew, correct torque is 664 lbf-ft (900 Nm).

4. Are the capscrews at the correct torque?
  - a. If Yes, then no further work is needed.
  - b. If No, then proceed to step 5.
5. Remove the two steering arm capscrews, and remove the steering arm.  
**Reference** section “Dissassembly of the Steering Knuckle” in the Front Axles chapter of the *Detroit Axles Manual* (DDC-SVC-MAN-0141).

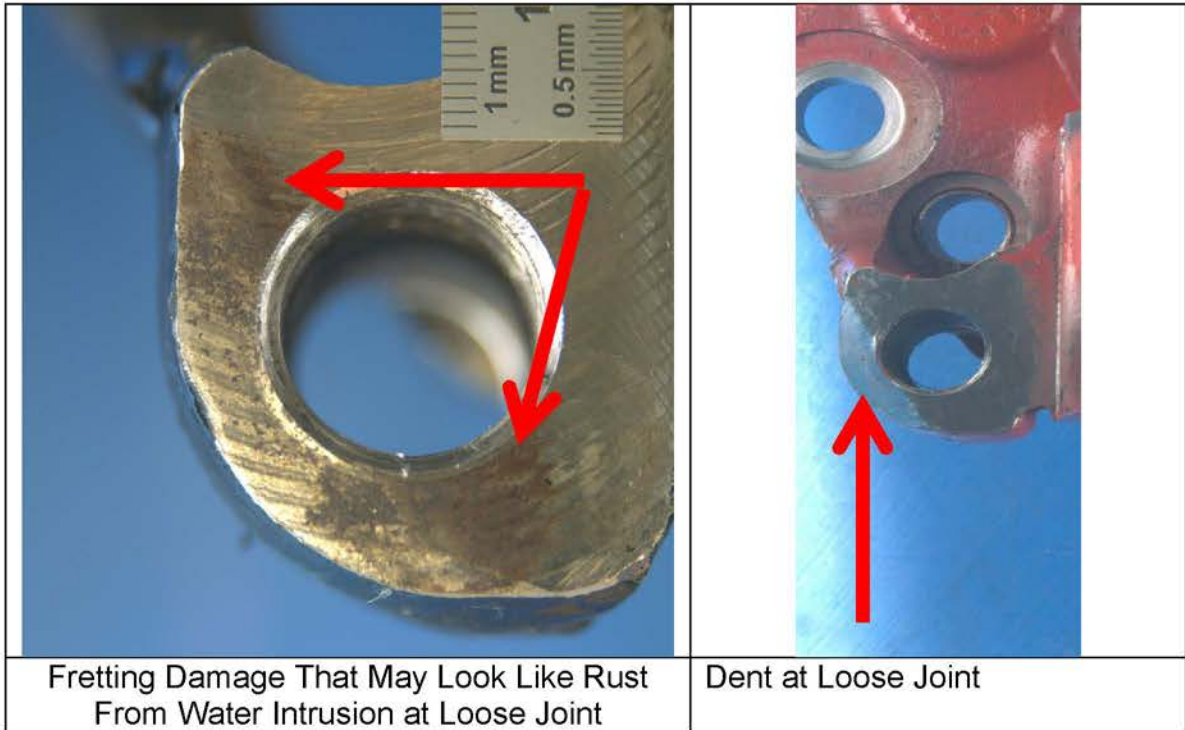
**Figure 2 – Damaged Joint Surfaces**

6. Inspect the joint surface between the steering arm and steering knuckle for signs of fretting, dents, or other damage from the loose capscrew(s). See Figure 2 for examples of damaged parts, and Figure 3 for an example of a new part.

7. Are the joint surfaces of either the steering arm or steering knuckle damaged?
  - a. If Yes, then proceed to step 8.
  - b. If No, then proceed to step 10.

8. **Remove the steering arm and steering knuckle.** Reference section "Dissassembly of the Steering Knuckle" in the Front Axles chapter of the *Detroit Axles Manual* (DDC-SVC-MAN-0141).
9. **Install a new steering arm and new steering knuckle.** Reference section "Assembly of the Steering Knuckle" in the Front Axles chapter of the *Detroit Axles Manual* (DDC-SVC-MAN-0141).
10. **Install two new steering arm capscrews.** Reference section "Assembly of the Steering Knuckle" in the Front Axles chapter of the *Detroit Axles Manual* (DDC-SVC-MAN-0141).
11. Repairs are complete.
