| Reference | SSM72108 |
| Models | LR4 / L319 |
| Title | 2015 LR4 Instrument Cluster Message Center Display Concern |

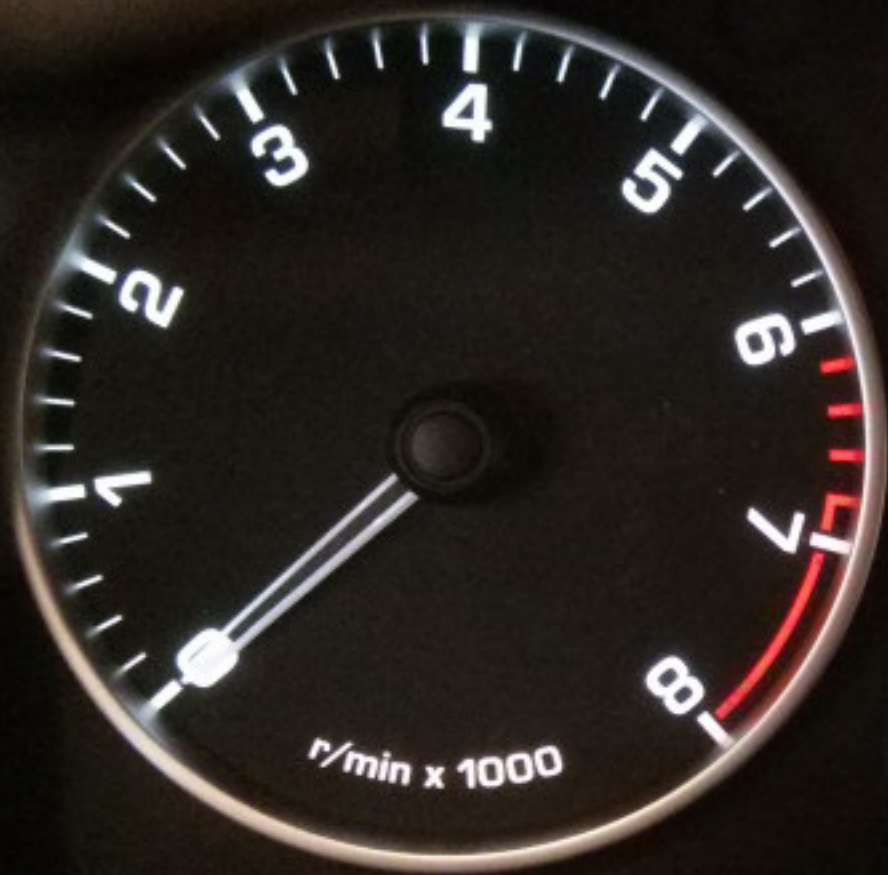
| Content | <p><b>***UPDATE***</b><br/><b><u>Instrument Cluster software, FH22-14C026-AD was released on DVD139, patch 17, calibration 200 to resolve this concern. This SSM will be removed once a bulletin is released to TOPIx.</u></b></p> <p><b><u>Model:</u></b><br/>2015 LR4</p> <p><b><u>Concern:</u></b><br/>A customer may state their Terrain Optimisation display in the Instrument Cluster Message Center does not correctly match the actual terrain mode which has been selected. Also the text in the Instrument Cluster Message Center, for the selected terrain mode, does not display correctly. "/BMP_TR_VEHICLE" is displayed instead of the correct corresponding text for the selected terrain mode.</p> <p><b><u>Cause:</u></b><br/>Instrument Cluster software fault for the "<i>English US</i>" language selection.</p> <p><b><u>Correction:</u></b><br/>New Instrument Cluster software is being developed and will be released as soon as possible. A further communication will announce the new software, when it becomes available.</p> <p>As an interim solution, the customer may select "<i>English UK</i>" from the Instrument Cluster display menu as follows:<br/><i>Main Menu &gt; Display Settings &gt; Language</i></p> <p>Until further notice it is recommended that the UK English language instrument cluster option is selected as a PDI default prior to vehicle delivery and that customers are advised to retain that language option to prevent display concerns.</p> <p><b>NOTE:</b> When the faulty message is shown, with "<i>English US</i>" selected, the improper display has no effect on the actual Terrain Response system. The Terrain Response switch displays the correct mode. There are no system performance related issues.</p> <p>For further clarification a photo has been attached showing the described concern.</p> |
