Reference	SSM72113
Models	Range Rover / L405 (000000 → 110440) Range Rover Sport / L494 (000000 → 000002)
Title	Diagnosis of PCM DTC P007B-00 Diagnostic (14-15MY 3.0L SC & 5.0L SC)
Category	Engine
Last modified	30-Mar-2015 00:00:00
Symptom	499000 Basic Engine
Attachments	11P007B images.pdf

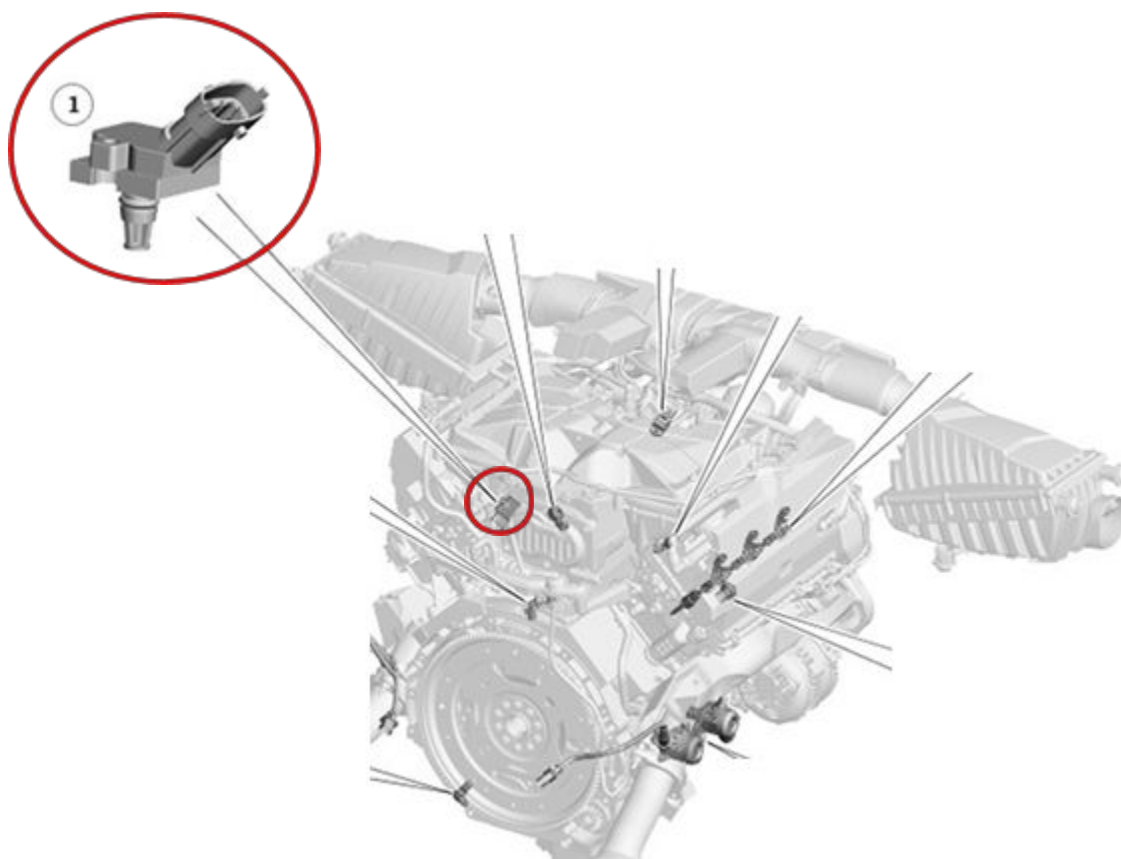
P007B-00 =TMAP or Charged Air Cooler Temperature sensor.

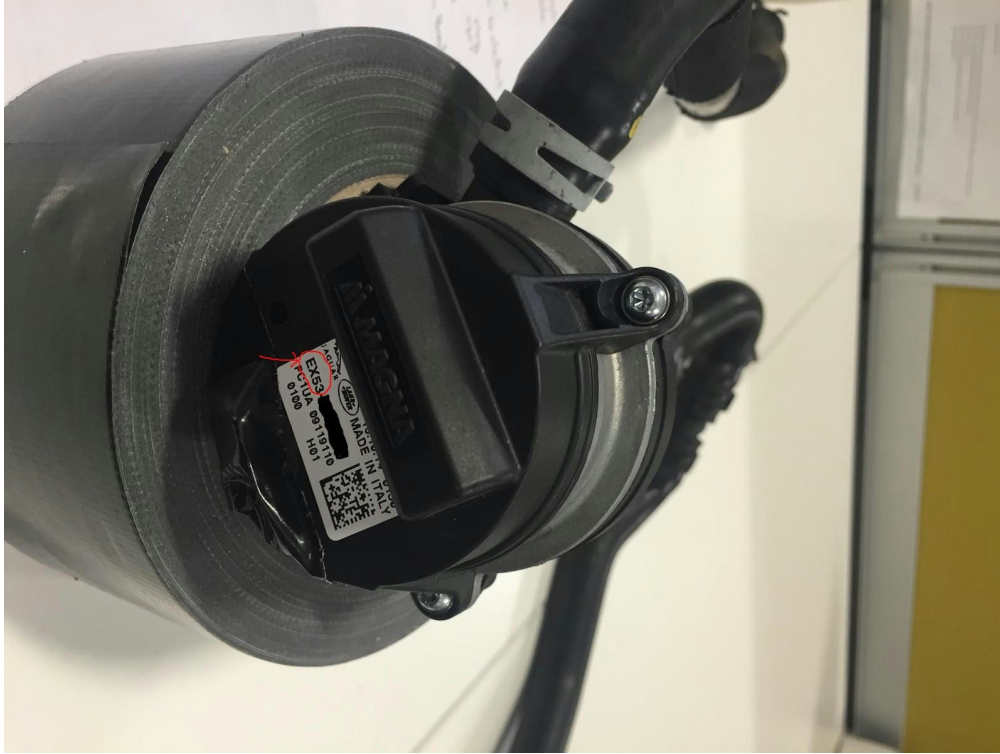
CAC Pump

Image of CAC pump and location of part number stamp. None EX53 parts may have stamps that can be seen on the side of the pump, as shown in the image below.

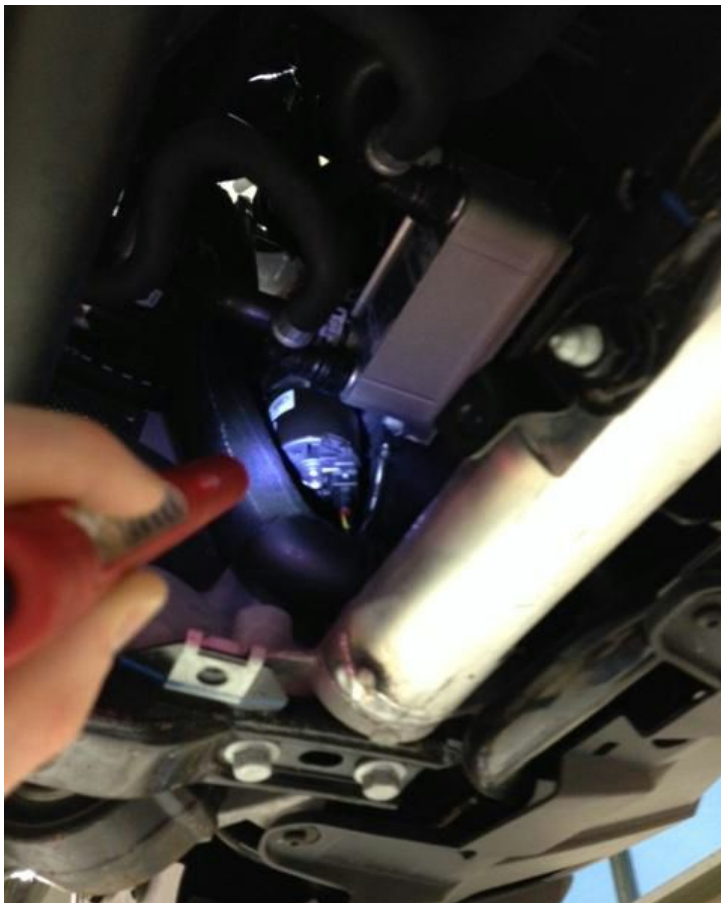
Remove undertray and CAC pump can be seen.
