Reference	SSM72193
Models	Discovery Sport / L550
Title	L550 Discovery Sport tailgate lamp water ingress and condensation
Category	Body
Last modified	02-Mar-2015 00:00:00
Symptom	110000 Sealing
Attachments	L550 Tailgate Lamps - Water Ingress 218.02.15.pdf
Content	<p><u>Issue:</u> Tailgate lamp water ingress/condensation</p> <p><u>Cause:</u> The lamp(s) are open back and seal against the tailgate thus any potential water ingress can filter through the lamp cavity and replacing of the lamp(s) will NOT cure the condition.</p> <p><u>Action:</u> Water ingress paths have been identified in the attached document. It is suggested that the root causes are investigated in the following order to achieve the correct repair.</p> <p>Potential root cause:</p> <ol style="list-style-type: none">1. Issue seen with lack of sealer in the indicated holeCorrective action is to remove the delinquent lamp in order to access the area and seal the hole with PU sealer.2. Issue seen with incorrectly fitted sealing patches as indicatedCorrective action is to remove the delinquent lamp in order to access the area and fit a new sealing patch. Patch service part number = BNP39963. Sealer omitted at point indicated

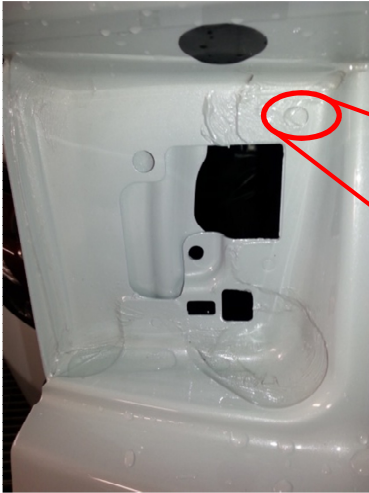
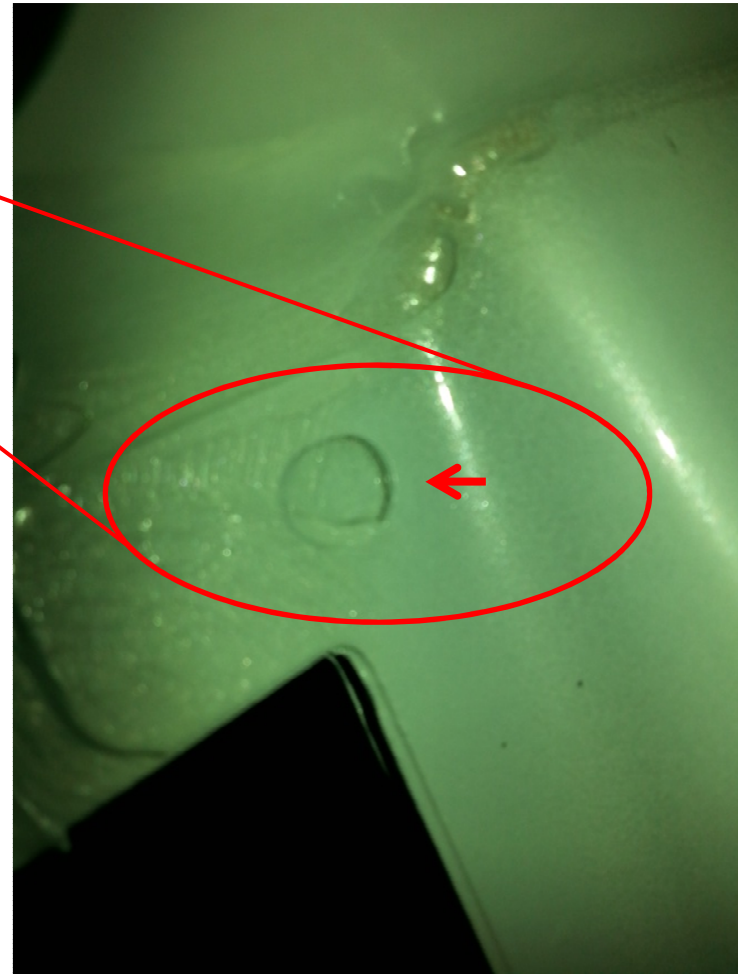
Tailgate lamp LH & RH water ingress - **potential root cause 1**
Absence of sealer in BIW hole to tailgate lamp bowls

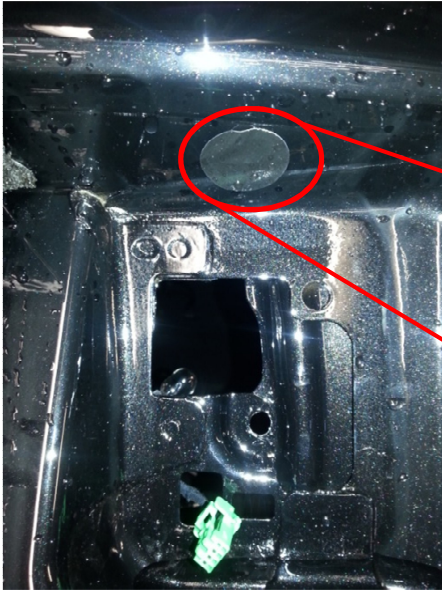
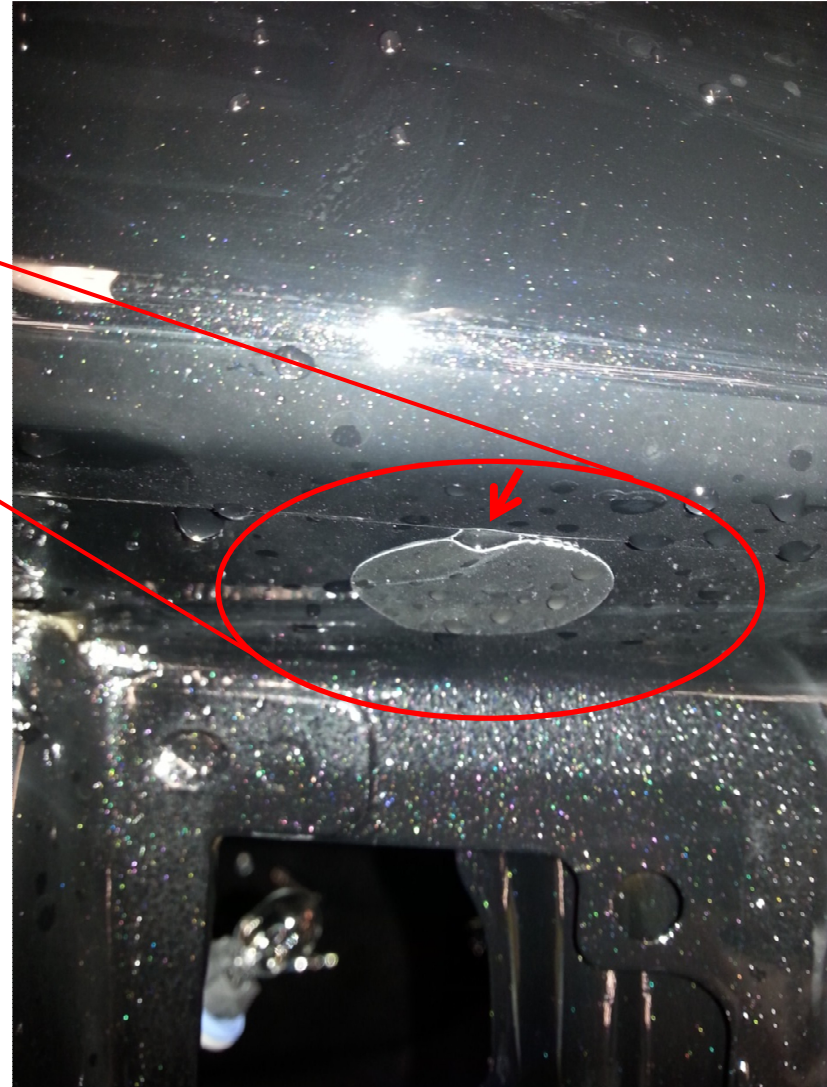
Tailgate lamp LH & RH water ingress - **potential root cause 2**

Poorly fitted sealing patch to underside of tailgate upper in lamp recess

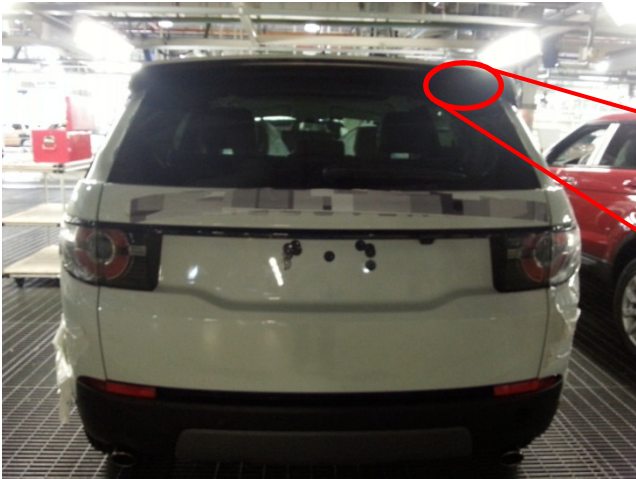
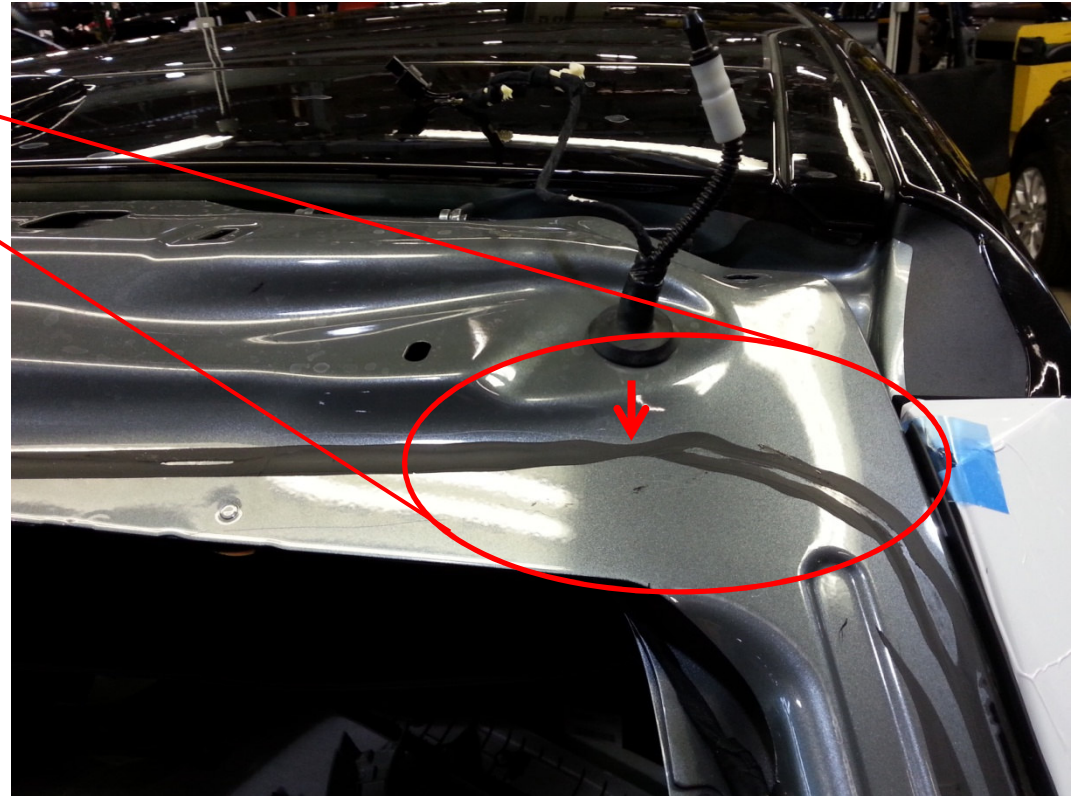
Tailgate lamp RH water ingress - potential root cause 3
Tailgate glass sealer PU skip
