# CAMPAIGN BULLETIN

Subject: **Field Service Campaign 15M1**  
**GHG14 DD Platform Software Reprogramming For Auto Elevate**

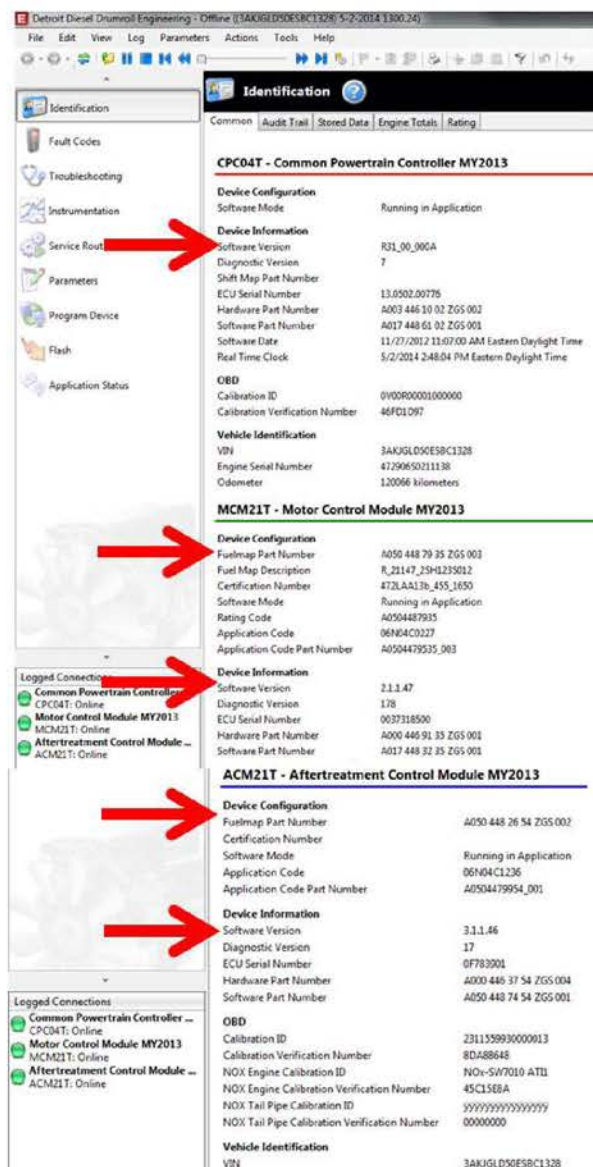
Figure 1 – DiagnosticLink Identification Screen

5. On the Identification screen, check the current software and fuel map levels. Listed below are the **MINIMUM** levels required. See Figure 1 for an example of the Identification screen.
  - a. MCM with **4.7.0.0** software and fuel map version **ZGS 001**.
  - b. ACM with **5.57.0.0** software and fuel map version **ZGS 001**.
  - c. CPC with **R34\_00\_000A** software.
  - d. For trucks equipped with the Detroit™ DT12™ transmission, TCM with **NAMT070700** software.

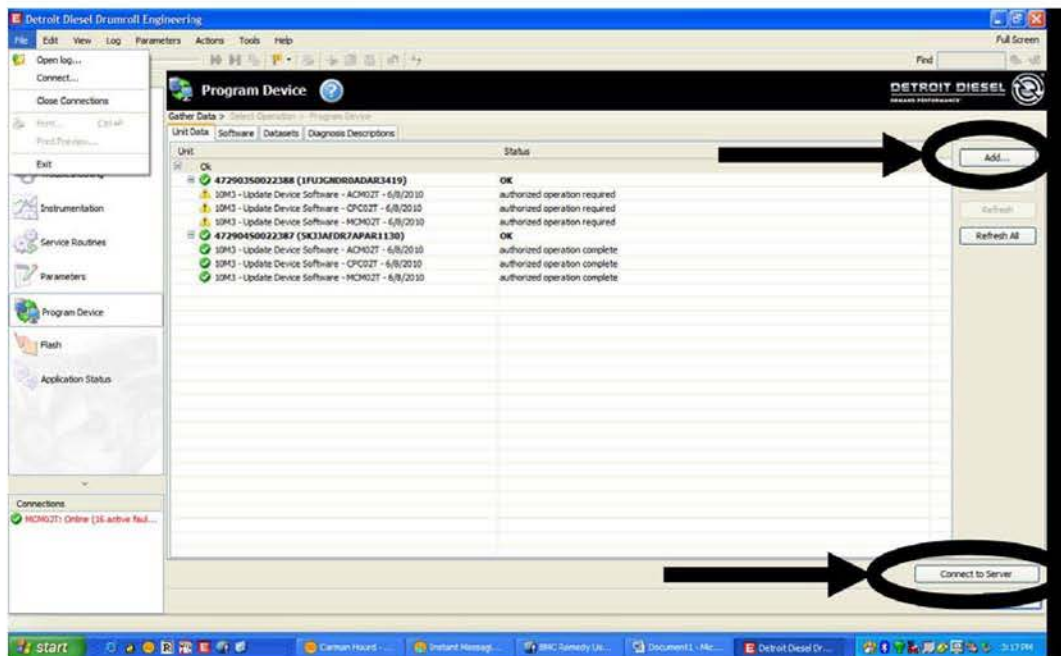
Figure 2 – Adding Engine Serial Number And Connecting To Server

6. Are the software and fuel map levels for the ACM, CPC, MCM, and if applicable, the TCM equal to or higher than the levels listed in step 5? All modules must meet the **MINIMUM** requirements.
  - a. If Yes for all modules, then no programming is necessary. Proceed to step 13.
  - b. If No for any or all modules, then proceed to step 7.
7. Select the "Program Device" option along the left side of the DiagnosticLink screen.
8. Select the "Add" button in the upper right corner of the DiagnosticLink screen and enter the engine serial number. Then click the "Connect to Server" button in the bottom right corner of the DiagnosticLink screen. See Figure 2.
