Subject: WATER ENTRY INTO TRUNK LID LIGHT DURING HIGH PRESSURE CAR WASH	Bulletin No: 09-021/15
	Last Issued: 05/27/2015

2014-2015 Mazda6 vehicles with VINs lower than JM1 GJ ***** 170534 (produced before January 29, 2014)

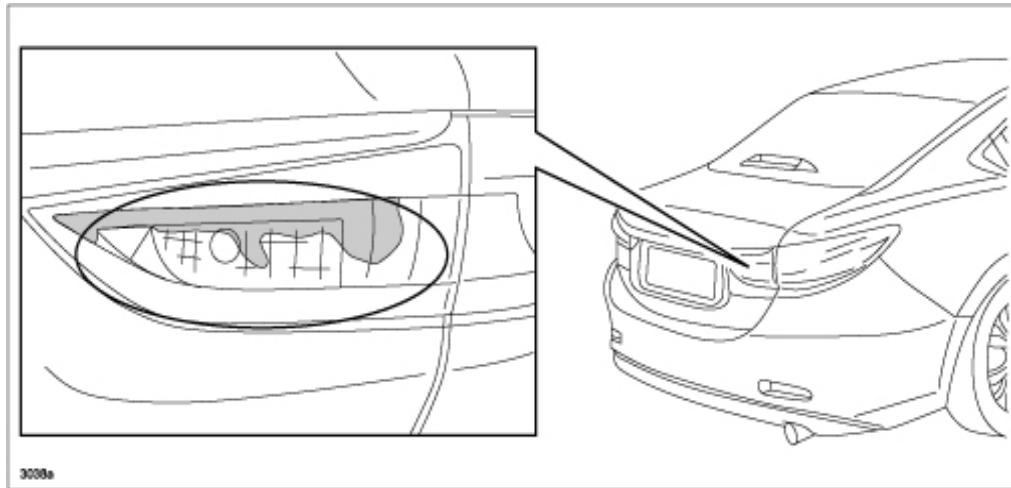
Some vehicles may exhibit a condition that water enters into the trunk lid light while washing the vehicle with high pressure. Water may enter through the trunk lid light gasket and the body panel.

Customers having this concern should have their vehicle repaired using the following repair procedure.
