Service Bulletin

Subject: Bulletin No: 01-009/15

CHECK ENGINE LIGHT ON WITH DTC P013A:00

2013-2016 CX-5

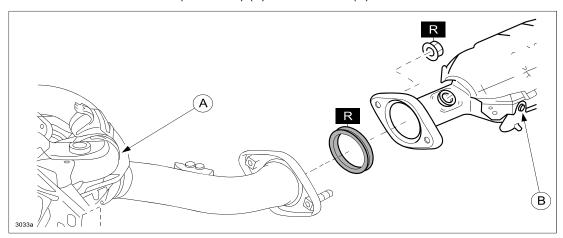
This concern may be caused by an impact from a speed-bump or other source, causing a deformation of the gasket between the exhaust manifold (WU-TWC) (A) and the TWC (B).

- 1. Verify the customer concern.
- 2. Inspect the exhaust system for a gas leak from the gasket.
- If a leak is detected from gasket, replace it with a modified part according to the instructions on MS3 online or the Workshop Manual (section 01-15 EXHAUST SYSTEM REMOVAL/INSTALLATION [SKYACTIV-G 2.0, SKYACTIV-G 2.5]).

- · Replace both flange nuts with new ones.
- Make sure to tighten the flange nuts to the specified torque spec.

Tightening Torque: 37.6 ft. lbf. {51 N-m}
