Subject: HOOD VIBRATION WHILE DRIVING AT HIGHWAY SPEED	Bulletin No: 09-019/15
	Last Issued: 05/19/2015

2013-2014 CX-5 vehicles with VINs lower than JM3KE*****387092 (produced before September 1, 2013)

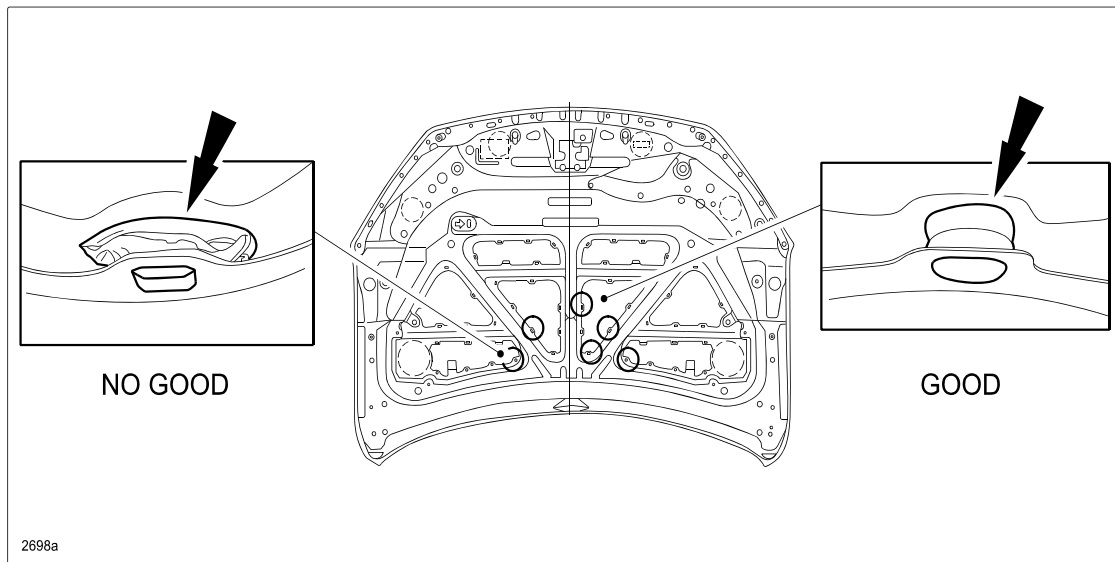
Some vehicles may exhibit a condition where the hood vibrates when driving at speeds of 110 Km/h (68 mph) or more.

The amount of sealant used to fill in the space between the inner frame and outer panel at the bottom area of the hood is insufficient. If the sealant detaches (as shown below on the left), it may cause the hood to vibrate. The amount of sealant has been increased during vehicle production and the preload force of the cowl grill seal has been increased to eliminate the concern.

The cowl grill seal will be replaced with a modified part, additional dampening material may be applied between the hood's inner frame and outer panel and the hood height may be adjusted to apply additional tension.
