<b>Subject:</b>  PAINT BLISTER / RUST SPOT ON LOWER LIFTGATE PANEL	<b>Bulletin No:</b> 09-018/15
	<b>Last Issued:</b> 05/19/2015

2013-2015 CX-5 with VINs lower than JM3 KE\*\*\*\*\* 523633 (produced before September 2, 2014)

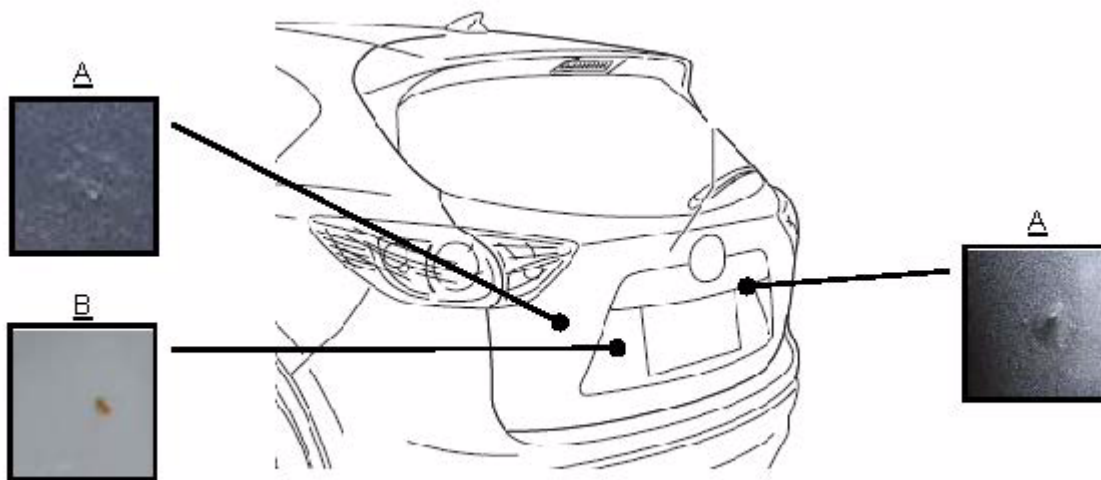
Some vehicles may exhibit a paint blister (A) and/or rust spot (B) on the lower portion of the liftgate panel as shown below.

The thickness of the paint may be insufficient, causing decreased corrosion resistance. However, the thickness of "clear" has been increased to eliminate this concern.

1. Verify the customer concern.
2. Repair any paint blisters and/or rust spots found on the lower portion of the liftgate using normal bodyshop repair procedures.
