Subject: CHIRP / CLUNK NOISE FROM REAR SHOCK ABSORBERS	Bulletin No: 02-005/15
	Last Issued: 05/18/2015

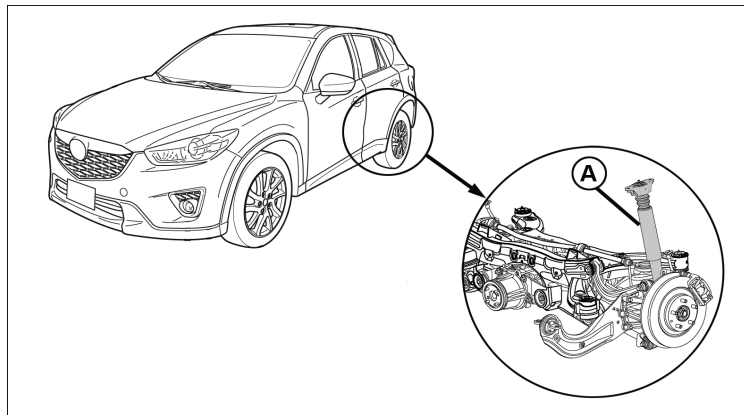
Some vehicles may exhibit a chirp/clunk type noise from the rear shock absorbers (A) when driving on a rough road or passing over a speed bump. Visual inspection of the shock absorbers show no external damage.

1. Verify customer concern.
2. Replace the rear shock absorber. Refer to MS3 online or Workshop Manual section 02-14:
 - CX-5 - REAR SHOCK ABSORBER REMOVAL/INSTALLATION
 - Mazda6 - REAR SHOCK ABSORBER REMOVAL/INSTALLATION

NOTE: Only replace the affected side.
