Subject: CHECK ENGINE LIGHT ON WITH DTC P0456	Bulletin No: 01-008/15
	Last Issued: 05/15/2015

2011-~~2015~~ Mazda3
~~2014-2016~~ Mazda6
~~2013-2016~~ CX-5
2007-2014 CX-9

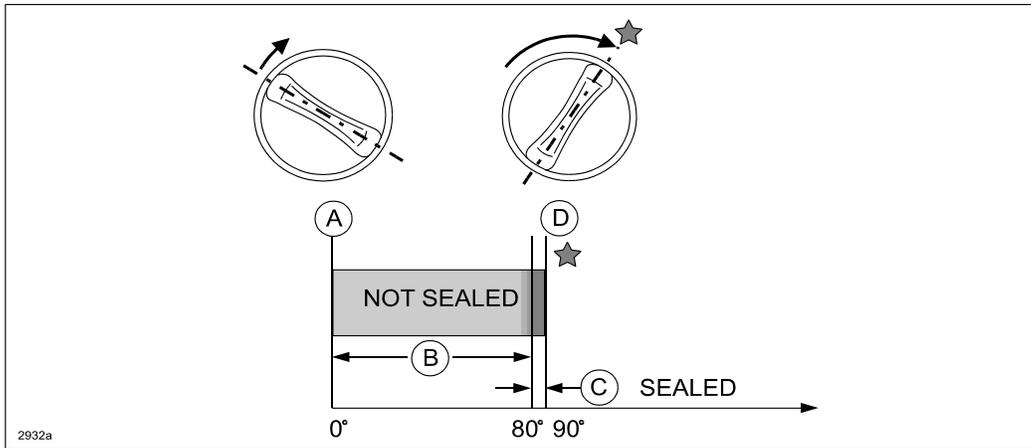
2011-13 MAZDA3, 2007-14 CX-9:

- **DO NOT** replace any parts without detecting a leak using MS3 / Workshop Manual diagnostics.
- **Explain to the customer that the fuel cap must be turned at least 80 degrees (C) or until two (2) or more click sounds are heard (D) to be properly sealed.**
- If the fuel cap is not completely closed, it may stay in the B range, (because the C range is so small) and will likely leak.

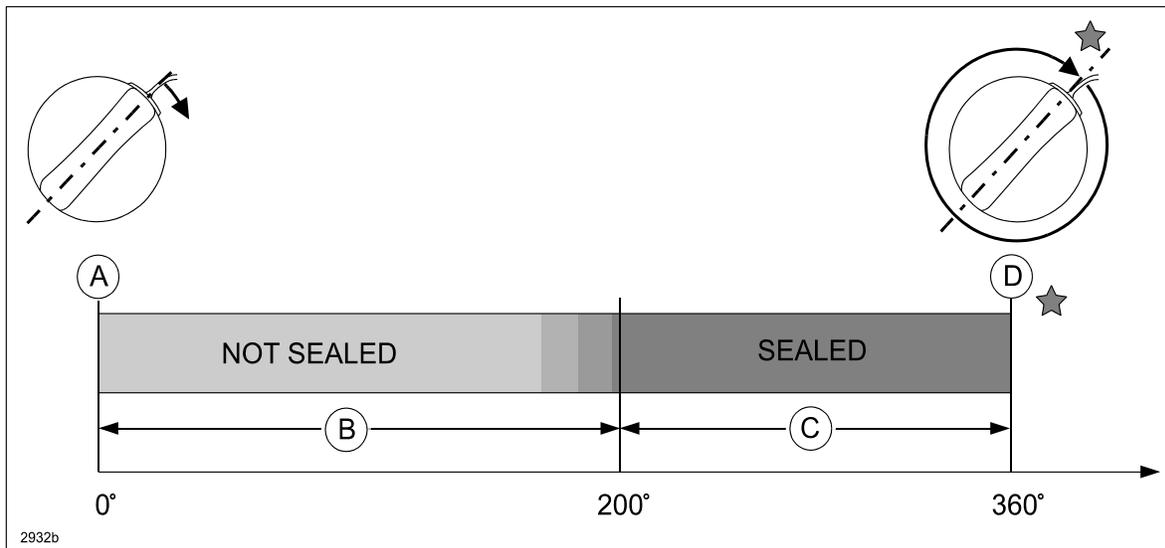
2014-15 MAZDA3, 2013-16 CX-5, 2014-16 MAZDA6:

- If the fuel cap is turned less than 200 degrees (B), it is not sealed.
- If the fuel cap is turned between 200 ~ 360 degrees (C), it is sealed.
- If the fuel cap is turned 360 degrees or more, it is sealed and a clicking noise (D) is also heard.

NOTE: The fuel cap may stay within the (C) range, since it is a large range. A leak is unlikely to occur, even if the fuel cap was not closed completely (until clicking sound is heard (D)).
