<b>Subject:</b>  FRONT SEAT BACK POCKET TORN	<b>Bulletin No:</b> 09-015/15
	<b>Last Issued:</b> 05/12/2015

2013-2015 CX-5

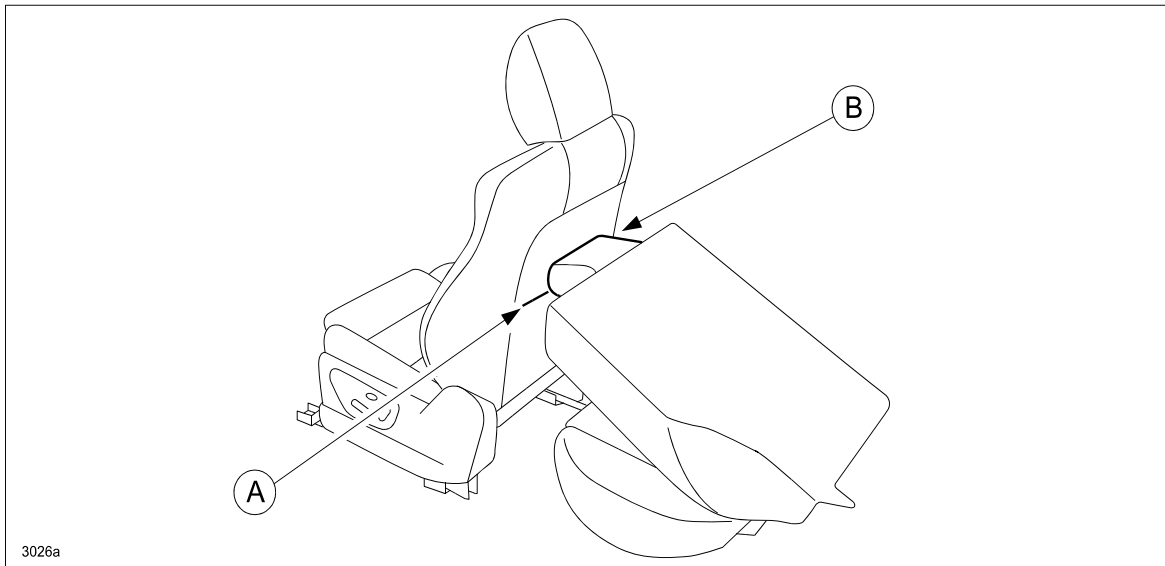
When folding the rear seat back forward, the head restraint (B) may catch on the front seat back pocket (A). If weight is applied to the rear seat at this time (i.e. passenger pushes on rear seat, etc.), the front seat back pocket may become torn.

1. Verify the customer concern.
2. Replace the affected front seat back trim (s) with a modified one according to MS3 online or the Workshop Manual (section 09-13 FRONT SEAT BACK TRIM REMOVAL/INSTALLATION).
3. Verify the repair.
