Subject: REAR DOOR SIDE GARNISH DETACHED (PEELING)	Bulletin No: 09-033/15
	Last Issued: 08/25/2015

2016 CX-3 vehicles with VINs lower than JM1 DK ***** 104149 (produced before June 03, 2015)

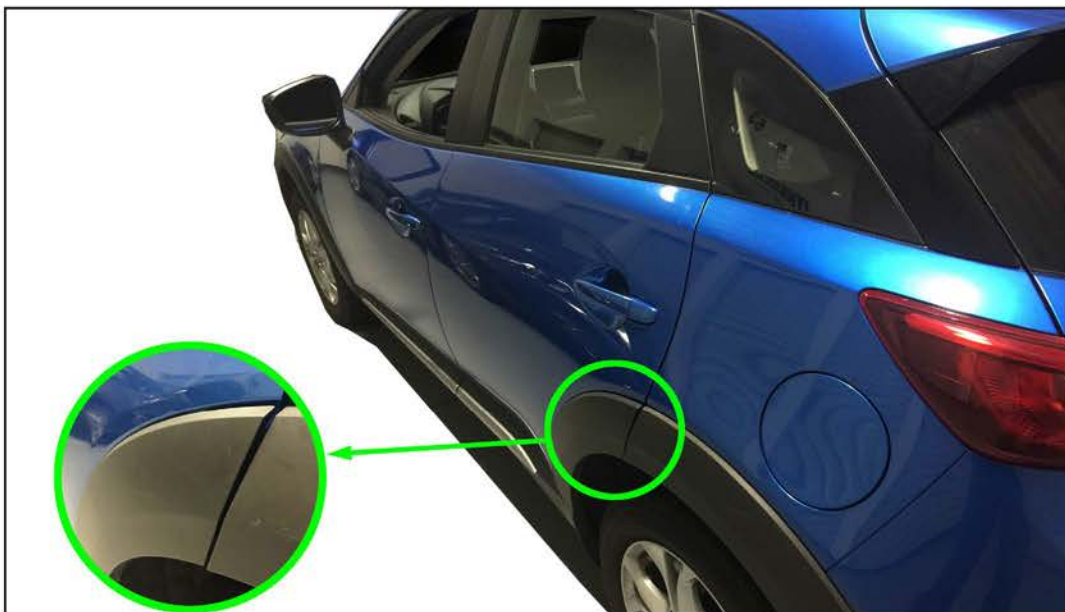
Some vehicles may exhibit the rear door side garnish detaching from the door (1 or both sides).

Customers having this concern should have their vehicle repaired using the following repair procedure.
