Service Bulletin

Subject:
 Bulletin No:
 01-020/15

CHECK ENGINE LIGHT ON WITH DTC P0300:00, P0301:00, P0302:00, P0303:00, AND/OR P0304:00
 Last Issued:
 08/18/2015

2012-2013 Mazda3 (with SKYACTIV)

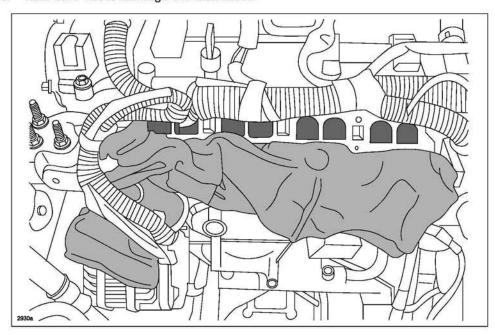
- 2. Check for carbon deposit around the intake valves.
- 3. Spread shop towels under the intake ports to protect components from cleaner overflow.

CAUTION: Take care not to damage the alternator.

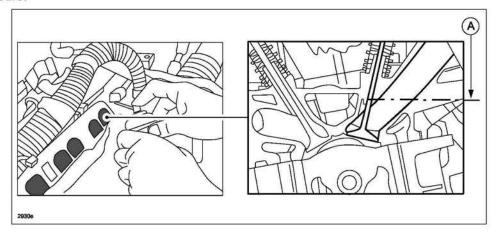
Carbon may be deposited around the intake valves, resulting in unstable engine combustion and misfiring during the accelerated warm-up system (AWS) operation.

- 6. Clean the intake valves of cylinders #1 and #4 with mark A at TDC.
 - a. Spray the cleaner fluid onto carbon deposit around the intake valves until fully covered (A) and let soak for 2 hours.
