Subject: DRIVER-SIDE POWER DOOR MIRROR VIBRATION	Bulletin No: 09-032/15
	Last Issued: 08/12/2015

2013-2015 CX-5 vehicles with VINs lower than JM3KE*****465579 (produced before April 1, 2014)

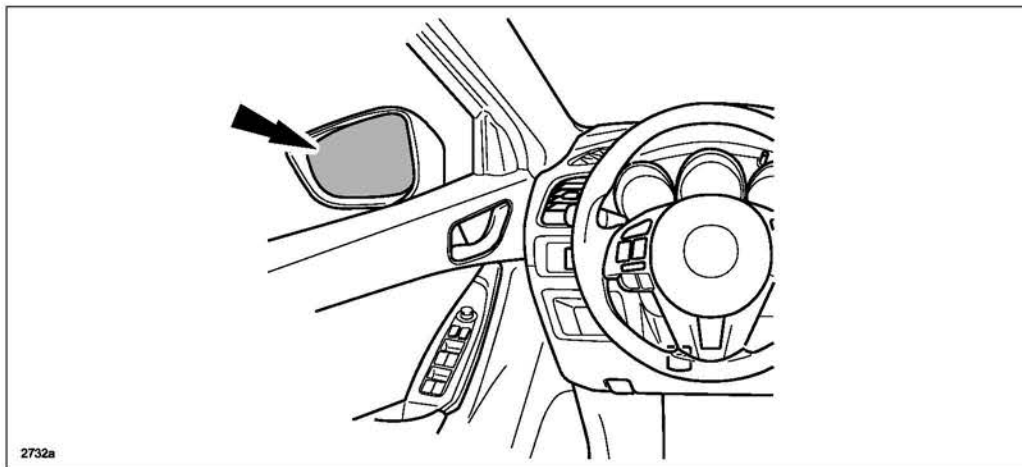
Some vehicles may exhibit a vibration from the driver-side power door mirror glass when the vehicle is driven at high speeds.

This concern may be due to a lack of rigidity of the mirror base so the mirror vibrates when it receives vehicle vibration or wind pressure.

An additional reinforcement has been installed inside the door to increase the door panel strength where the door mirror is mounted. Also, the door mirror shape has been changed. Both of these modifications have been implemented to eliminate mirror glass vibration concerns.
