<b>Subject:</b> UNUSUAL NOISE WHEN STARTING TO MOVE VEHICLE WHILE STEERING WHEEL IS TURNED TO FULL LEFT POSITION	<b>Bulletin No:</b> 06-001/15
	<b>Last Issued:</b> 08/12/2015

## BULLETIN NOTE

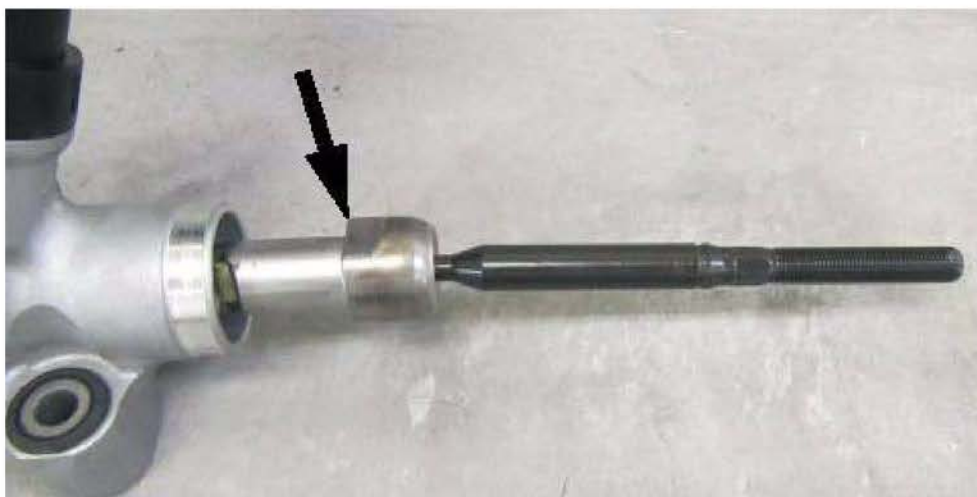
The noise is caused when the edge of the left side inner ball joint gets stuck with the steering gear housing.

To eliminate the noise, the shape of the inner ball joint edge has been changed.
