<b>Subject:</b>  CHECK ENGINE LIGHT ON WITH DTC P2610 AND P2507	<b>Bulletin No:</b> 01-018/15
	<b>Last Issued:</b> 08/06/2015

- 2013-2016 CX-5
- 2014-2016 Mazda6
- 2014-2016 Mazda3
- 2016 CX-3
- 2016 MX-5

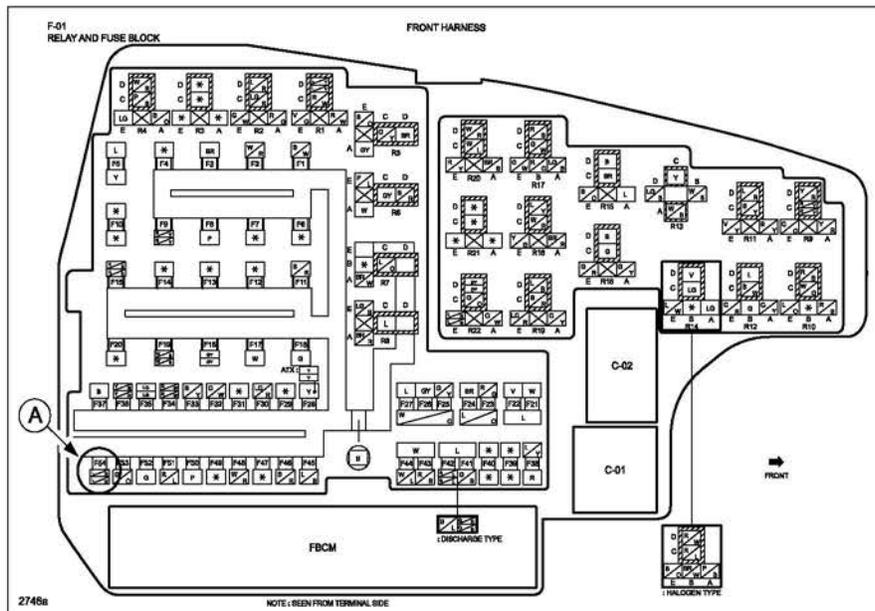
Some vehicles may experience the CHECK ENGINE LIGHT ON with DTC P2610 and P2507 stored in memory after engine start and room fuse 15A (A) removed.

- P2610:00: Instrument cluster internal engine off timer performance problem
- P2507:00: PCM battery voltage low input

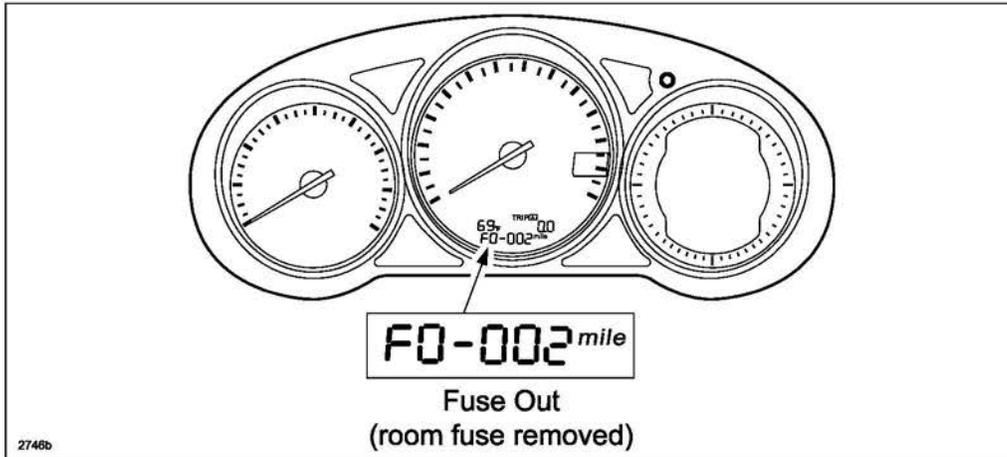
**NOTE:** The odometer will display "F0-002" during transport mode (room fuse 15A removed). Transport mode is canceled when room fuse 15A is installed or the vehicle odometer is more than 12.4mi (20km).
