<b>Subject:</b>  CHECK ENGINE LIGHT ON WITH DTC P0421	<b>Bulletin No:</b> 01-016/15
	<b>Last Issued:</b> 08/04/2015

## APPLICABLE MODEL(S)/VINS

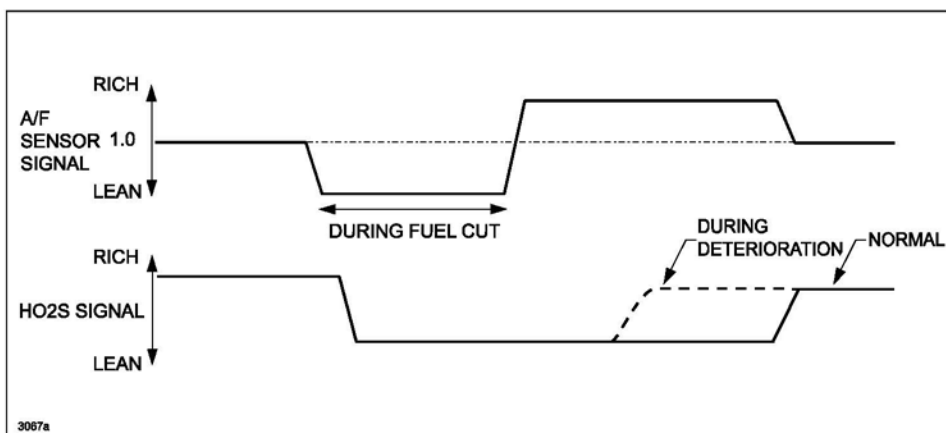
Catalyst monitor function explanation

- The PCM monitors the oxygen storage amount proportional to catalytic converter purification characteristic.
- The PCM starts to monitor after recovery (fuel injection starts) from fuel cut control.
- The PCM temporarily changes the target air/fuel ratio to rich at fuel cut recovery, and detects the response time until the HO2S output signal outputs the voltage on the rich side.
- If the catalytic converter purification characteristic deteriorates, the amount of the time until the HO2S detects the voltage on the rich side is shorter compared to the normal purification characteristic as shown. The PCM detects a catalytic converter malfunction using this characteristic.

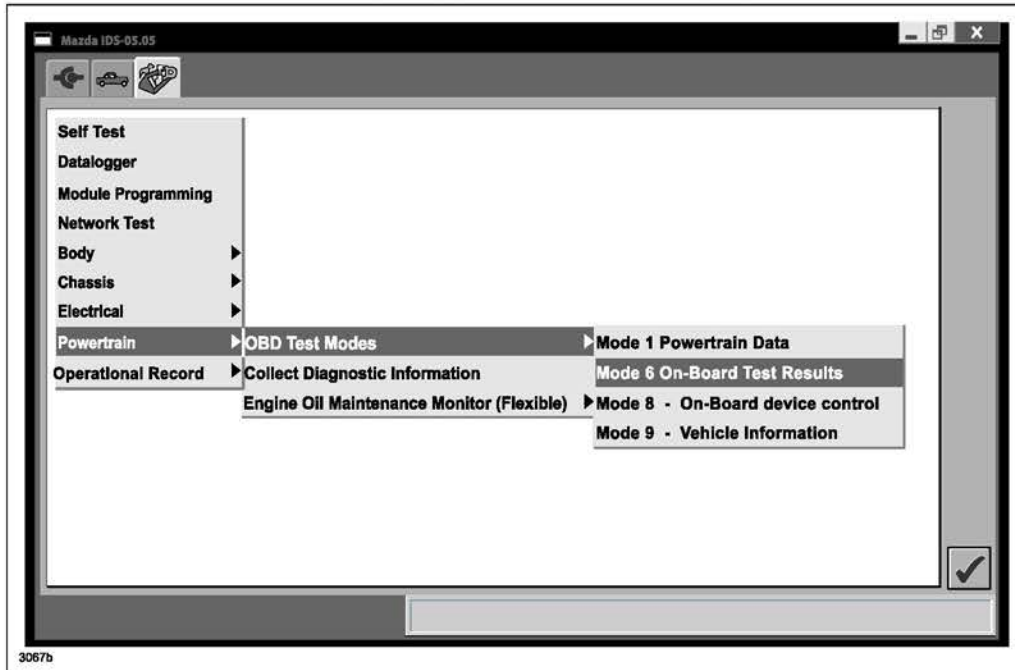
1. Verify the condition of the Warm Up Three-Way Catalytic Converter (WU-TWC) by checking the value "Catalyst monitor bank 1" on MODE6 with M-MDS.
  - a. Go to Powertrain => OBD Test Modes => Mode6 On Board Test Results
