© 2015 Mazda Motor of America, Inc.

Subject: FRONT POWER SEATS DO NOT SLIDE BACK AND FORTH	Bulletin No: 09-034/15
	Last Issued: 08/25/2015

2013-2016 CX-5 vehicles with VINs lower than JM3KE*****663237 (produced before May 1, 2015)

2014-2016 Mazda6 vehicles with VINs lower than JM1GJ*****430009 (produced before May 1, 2015)

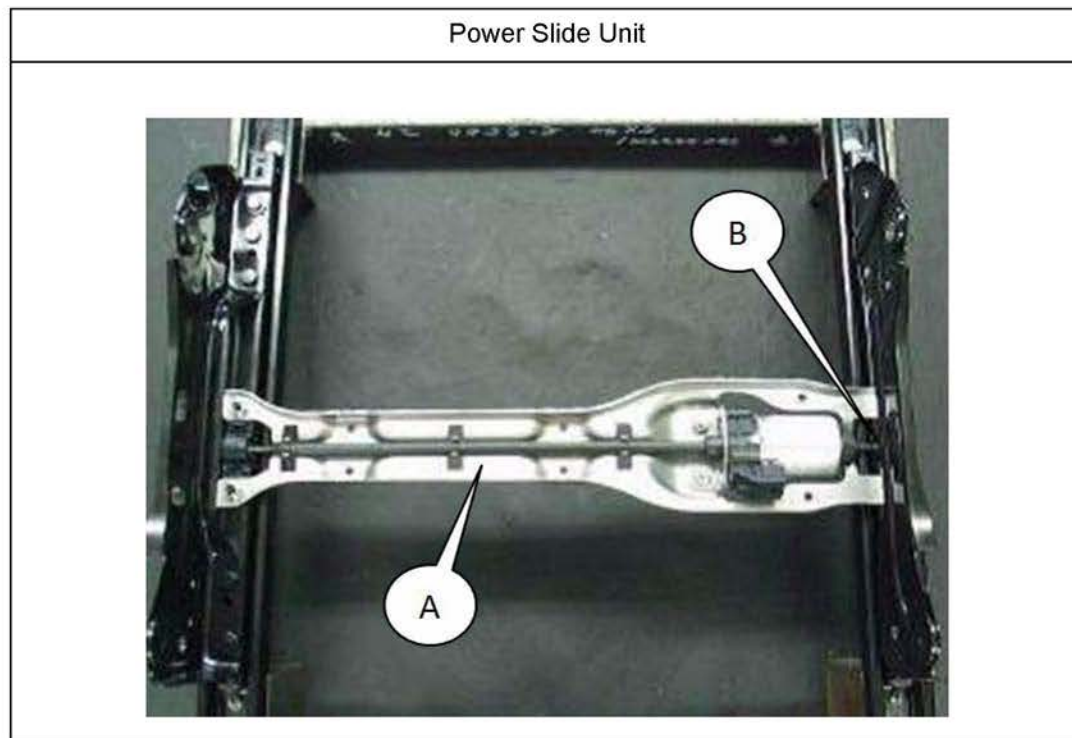
Some customers may complain that the front power (driver and/or passenger) seats do not slide back and forth properly or that they may be completely inoperative. This concern may be caused by a foreign object getting stuck under the power slide unit (below) while in operation. This can cause motor mounting bracket (A) deformation, resulting in motor cable (B) breakage.

To eliminate this concern, the shape of the motor mounting bracket (A) has been modified to increase its strength.

Customers having this concern should have their vehicle repaired using the following repair procedure.

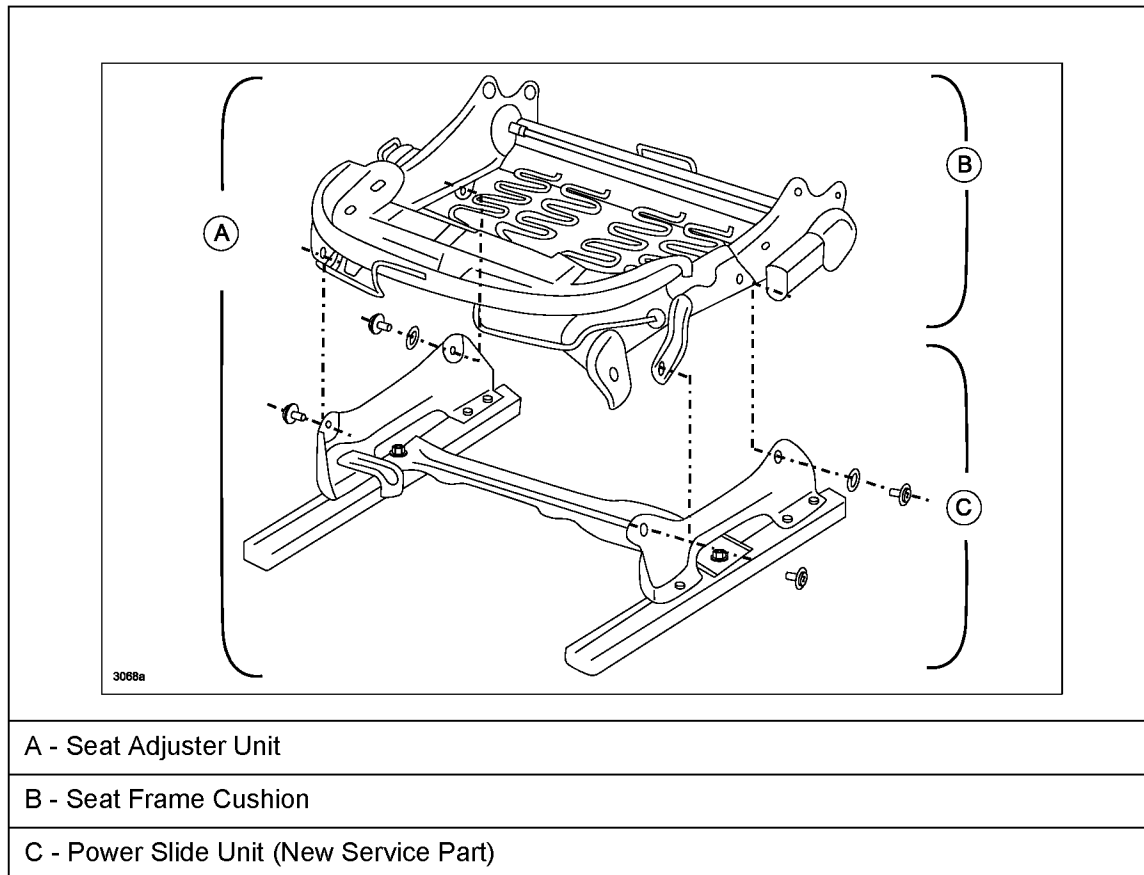
1. Verify the customer concern.
2. Inspect the motor cable (short one) and the motor mounting bracket:
 - Is the motor cable broken?
 - Is the motor mounting bracket deformed?
3. If the results are "Yes" for either of the above inspections, replace the power slide unit with a newly established modified service part according to the replacement procedure.
