<b>Subject:</b> <b>2013-2014 CX-5 - VARIOUS ELECTRICAL SYSTEM MALFUNCTION(S) RELATED TO C-15 CONNECTOR CORROSION</b>	<b>Bulletin No:</b> 09-041/15 <b>Last Issued:</b> 10/14/2015
---	---

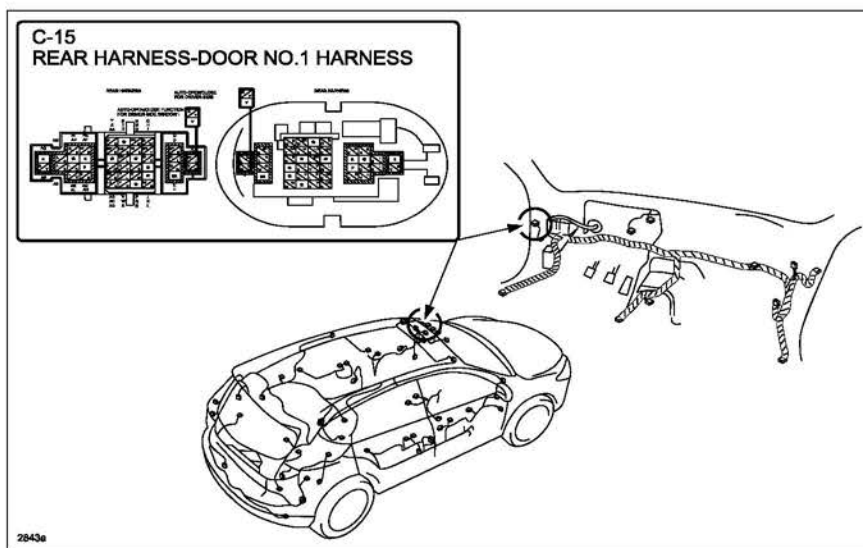
The symptoms listed above may be caused by corrosion of the C-15 connector terminals due to water intrusion through the front door. In low ambient temperatures, the door harness hardens. If the door is fully opened, it may create a gap between the door and the door harness grommet, which may allow water to enter through the gap.

If one or more of the above mentioned symptoms can be confirmed, disconnect the C-15 connector (which joins the door harness and the rear harness). Inspect for any signs of corrosion of the C-15 connector terminals referring to the inspection procedure below.

- If there is any corrosion at the C-15 connector, replace the door harness and repair the rear harness according to the following repair procedure.
  - If there is no corrosion found at the C-15 connector, this bulletin is not applicable. Troubleshoot the concern(s) according to the MS3 online instructions or the Workshop Manual.
1. Verify the customer concern.
  2. Record customers pre-set radio stations.
  3. Slide the driver side front seat fully backwards.
  4. Disconnect the negative battery cable.
  5. Disconnect the C-15 connector according to the MS3 online instructions or the Workshop Manual (section 09-11 FRONT DOOR REMOVAL/INSTALLATION).
  6. Inspect for any corrosion found on the terminals shown below.

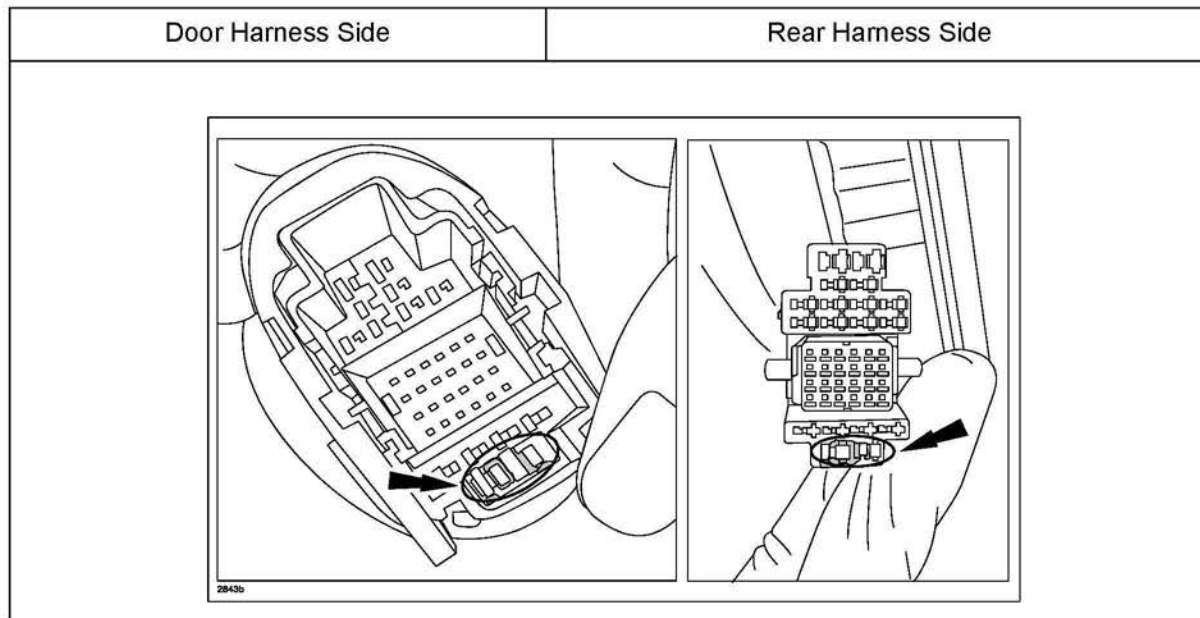
- If there is any corrosion found on the terminals, go to next step.
- If there is no corrosion found on the terminals, this bulletin is not applicable. Troubleshoot the concern(s) according to the MS3 online instructions or the Workshop Manual.
