Service Bulletin

NOISE FROM REAR DIFFERENTIAL MOUNT(S)
Last Issued: 10/14/2015

2007-2015 CX-9 AWD with VINs lower than JM3TB*****468329 (produced before Aug. 1, 2015)

Bulletin No: 03-007/15	Last Issued: 10/14/2015
© 2015 Mazda Motor of America, Inc.

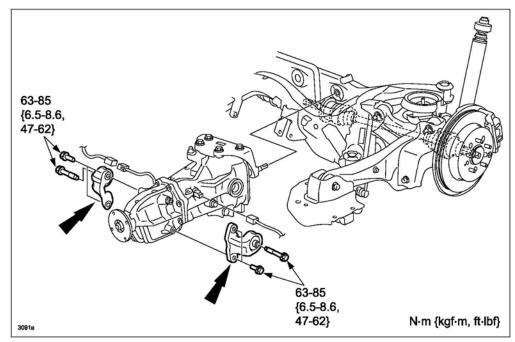
Due to environmental heat and heat from the exhaust system, the rear differential mounting rubber may become hardened and cracked, resulting in vibration and/or noise.

- 1. Verify the customer concern.
- 2. Inspect the left and right side mounts for cracks in the rubber.
 - If cracks are found in either side mounting rubber, proceed to Step 3.
 - If no cracks are found in either side mounting rubber, this service bulletin does not apply. Refer to MS3
 online or the Workshop Manual for further troubleshooting.

3. Replace the mounting rubber(s) with a modified one according to the instructions on MS3 online or the Workshop Manual (section 03-14 REAR DIFFERENTIAL REMOVAL/INSTALLATION).

- Mounting rubber(s) can be replaced without removing the rear differential or propeller shaft from the vehicle.
- Replace only the affected side mounting rubber.
- 4. Verify the repair.
