Subject: UNUSUAL NOISE WHEN STARTING TO MOVE VEHICLE WHILE STEERING WHEEL IS TURNED TO FULL LEFT POSITION	Bulletin No: 06-001/15
	Last Issued: 10/07/2015

2014-2015 Mazda3 vehicles with VINs lower than JM1BM*****233957 (produced Sept. 22, 2014)

2014-2015 Mazda6 vehicles with VINs lower than JM1GJ*****210201 (produced Sept. 22, 2014)

2013-2015 CX-5 vehicles with VINs lower than JM3KE*****531471 (produced Sept. 22, 2014)

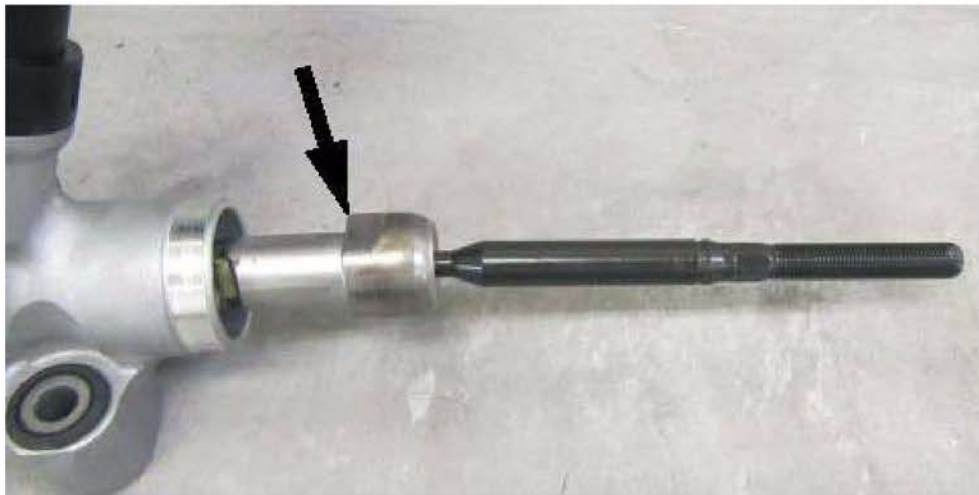
Some vehicles may exhibit an unusual thumping noise from under the front of the vehicle. This noise only occurs when starting to move the vehicle while the steering wheel is turned to the full left position.

The noise is caused when the edge of the left side inner ball joint gets stuck with the steering gear housing.

To eliminate the noise, the shape of the inner ball joint edge has been changed.
