Reference	SSM72324
Models	Discovery Sport / L550
	Range Rover Evoque / L538
Title	Trim finishers and body damaged/marked
Category	Body
Last modified	01-Jul-2015 00:00:00
Symptom	108000 Ext. Trim/Accessories
Attachments	damage.pdf
Content	Issue:
	Now vahiolog arriving at Ports or Potailors are being reported to have damage but without sufficient information to understand the

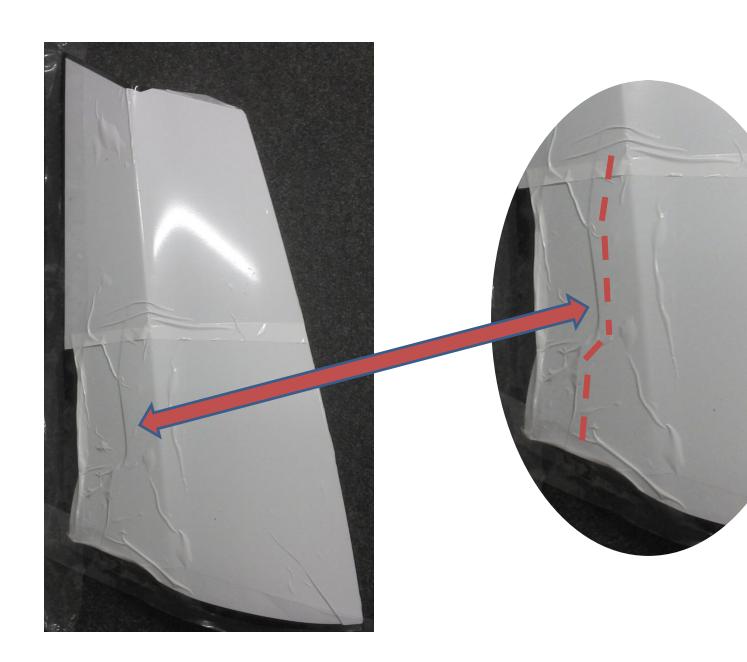
Inspect vehicle protective covers - film or body cover, for potential damage to the parts underneath. Example: cracks should appear as creases through the white protective film as seen in the attached file.

Please report any damage through an EPQR and add photo's of both the protection damage and the part.
