TECHNICAL BULLETIN  
LTB00542NAS2  
27 AUG 2015

**SECTION: 204-04**

Tire Pressure Monitoring System - Improved Diagnostics and Service Information

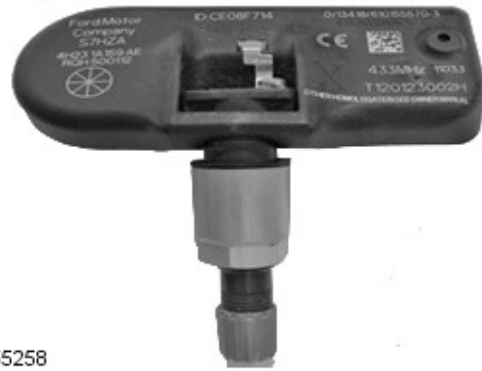
E155258

9. **TG1B Sensor** - non-serviceable valve stem

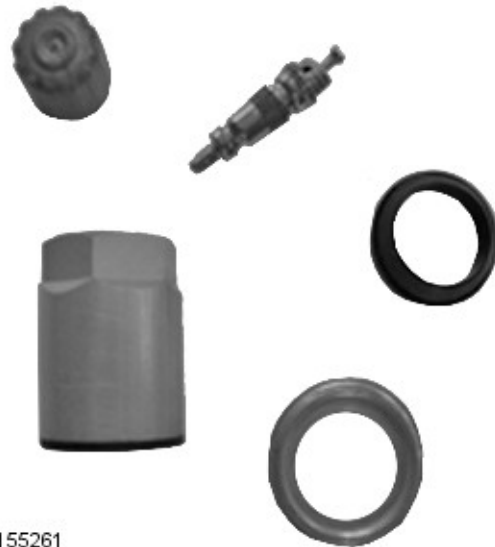
E155261

**10. TG1B Service kit** - hardware and seals only; no valve stem

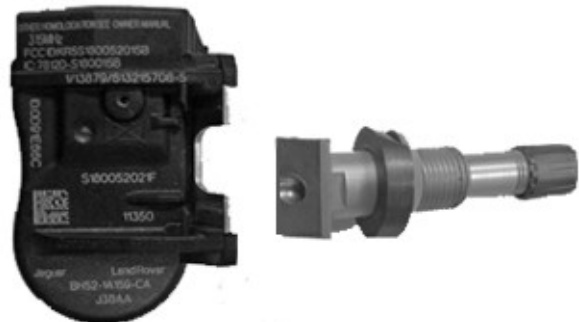
E155257

**11. TG1C Sensor** - serviceable valve stem

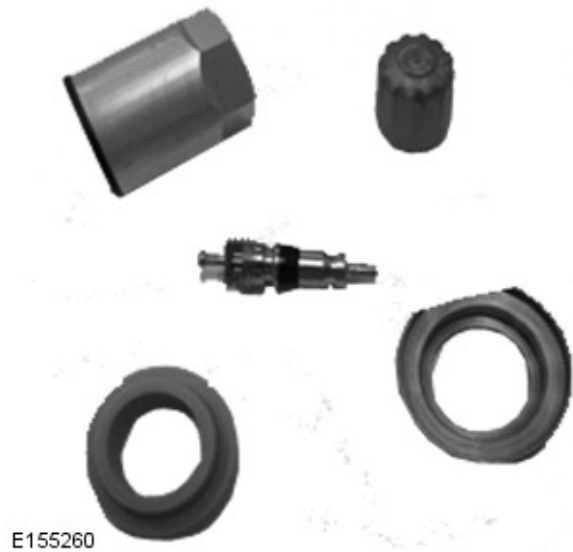
**12. TG1C Service kit** - hardware and seals **only**; no valve stem

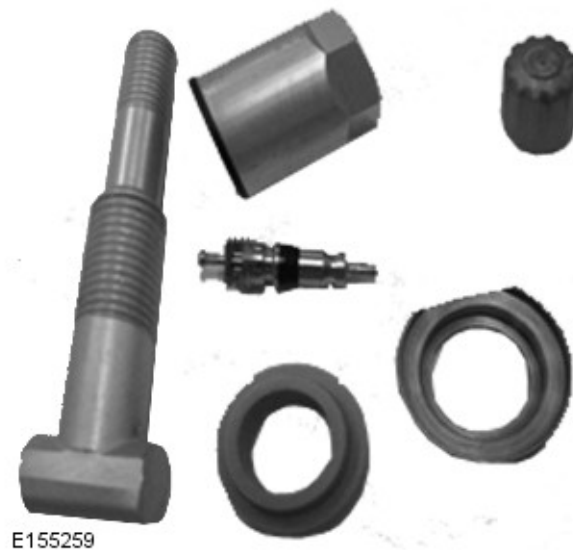
**13. TG1C Service kit** - hardware, seals, and valve stem
