TECHNICAL BULLETIN
LTB00695NAS3
07 AUG 2015

SECTION: 205-00

Vibration in 7th/8th Gear at High Speed

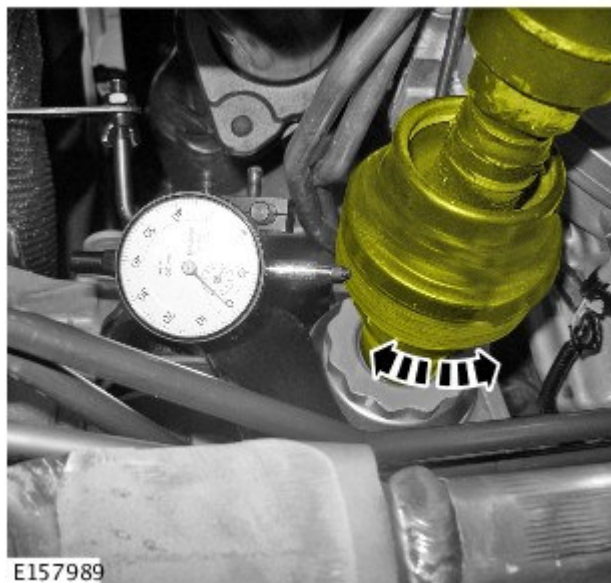
5. Hold one of the front wheels in position and rotate the other to measure the Total Indicator Reading (TIR) of the joint head.

- Record the TIR value.

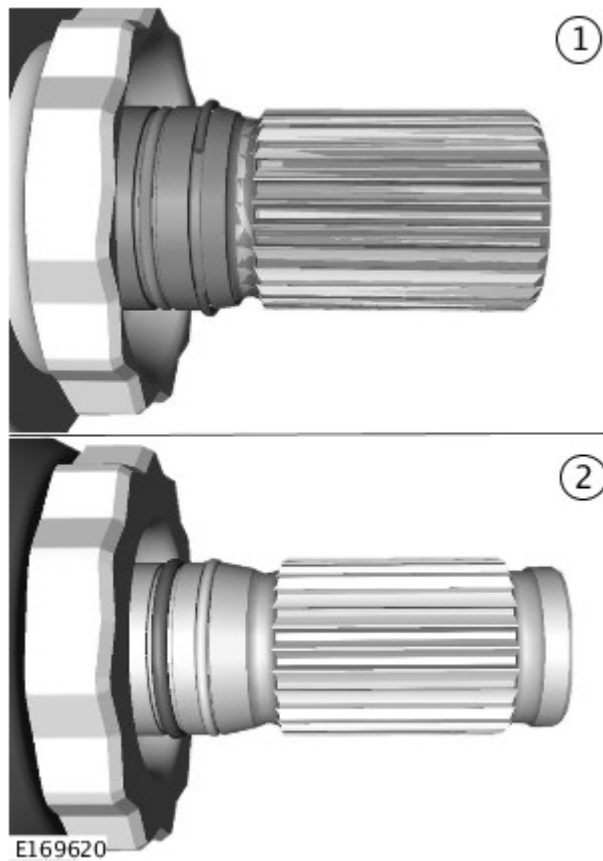
**NOTE: the fitted pinion type will affect the action required during Service Instruction 'B'.**

Identify the currently fitted front differential pinion type:

- (1) Old type
- (2) Modified type

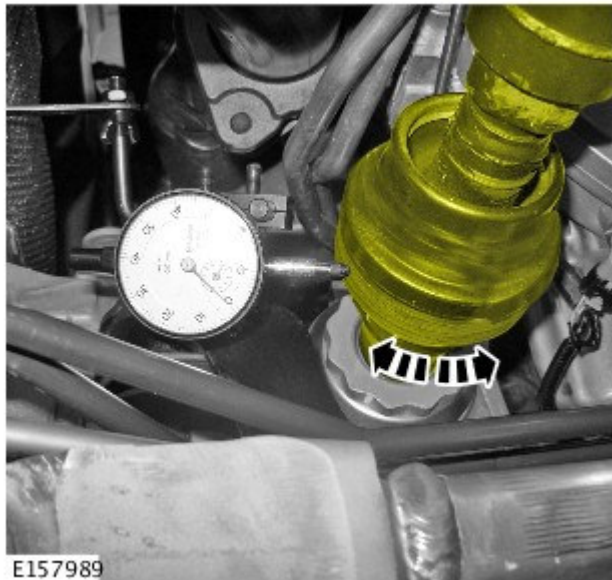
Hold one of the rear wheels in position and rotate the other to measure the Total Indicator Reading (TIR) of the joint head.

- Record the TIR value.

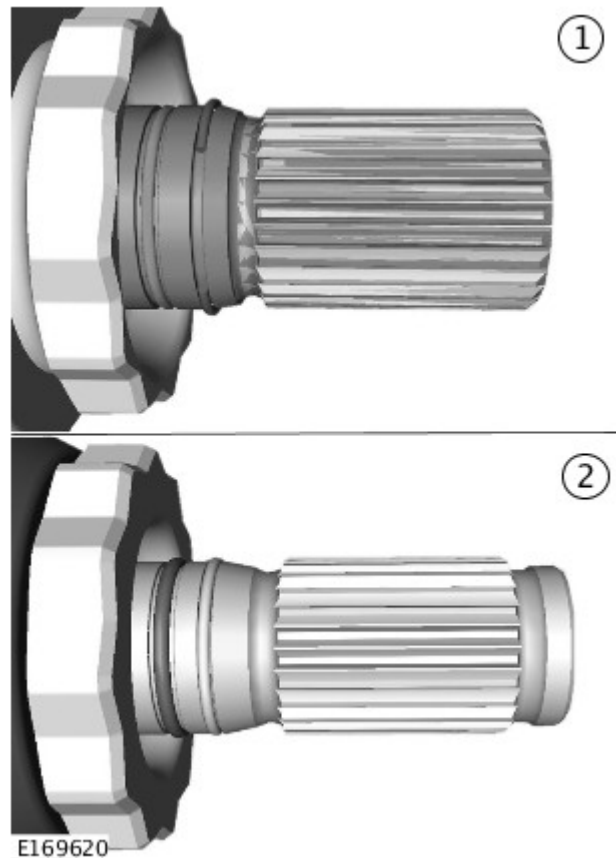
**NOTE: vehicles already fitted with the modified front differential (2) do NOT require the front differential to be replaced.**

As identified in Service Instruction 'A', step 8:

- (1) 'Old' type
 - If the vehicle is fitted with the 'Old' type (1) front differential pinion, continue to step 2.

- (2) 'Modified' type
 - If the vehicle is fitted with the 'Modified' type (2), continue to step 3.

If vibration still present after performing Service Instruction 'A' and the vehicle is fitted with the 'Old' type (1) front differential, replace the front differential and the front driveshaft with the latest production parts to reduce eccentricity at coupling (see TOPIX Workshop Manual, section 205-03).

If vibration still present after performing Service Instruction 'A' and the vehicle is fitted with the 'New' type (2) front differential, replace only the front driveshaft with the latest production parts to reduce eccentricity at coupling (see TOPIX Workshop Manual, section 205-03).
