TECHNICAL BULLETIN  
Q489NAS1  
10 AUG 2015

Service Action: Second Row Seat Squeaks and Rattles

**Discovery Sport (LC)**

**Model Year:** 2015-2016  
**VIN:** 501001-518432  
**Manufacturing Plant:** Halewood

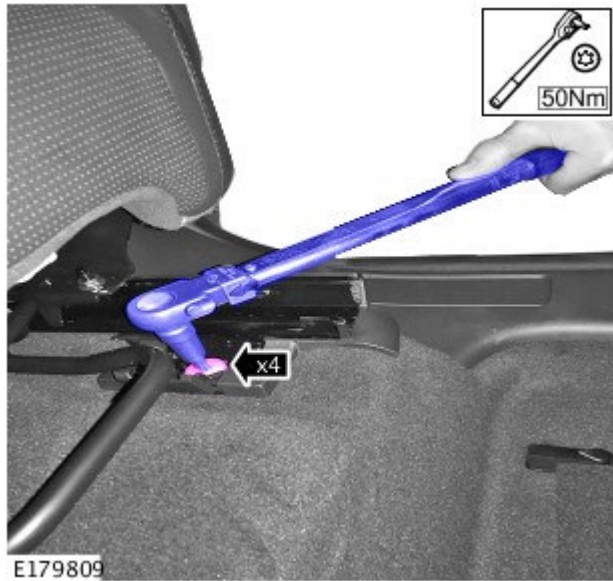
**Situation:** An issue has been identified on a limited number of 2015-2016 model year Discovery Sport (L550) vehicles where the forward 4 X M10 fixings (inboard and outboard) and the rearward (inboard only) fixings of the second row seats may have residual torque below the minimum specified limit.

Tighten the four second row seat front fixings.

- Torque: 50 Nm
