# TECHNICAL BULLETIN

## Q499NAS1

Service Action: Early-Life Corrosion to Brackets Welded to Fuel Tank Shield

#### **Discovery Sport (LC)**

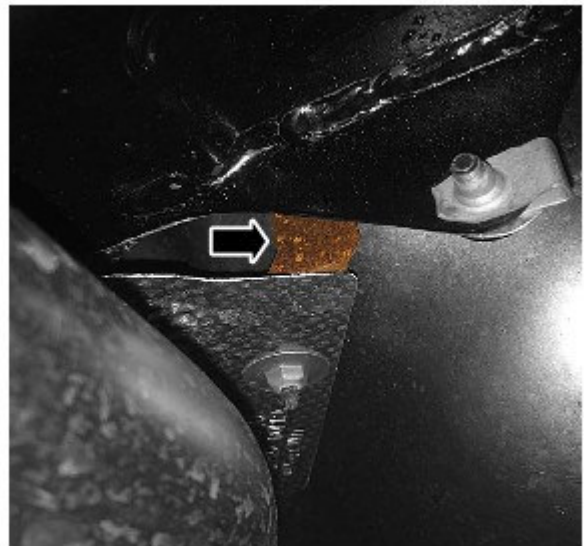
E181028

1. Raise the vehicle (see TOPIx Workshop Manual, section 100-02).
2. Inspect the fuel tank shield bracket for corrosion.

6. If the fuel tank shield brackets (shown in Steps 2 - 5) have no corrosion, lower and release the vehicle. No further action required.
  - If any of the fuel tank shield brackets shown in Steps 2-5 have corrosion, continue to Step 7.
7. Remove the fuel tank for access only (see TOPIx Workshop Manual, section 310-01).
8. Remove and discard the fuel tank shield.

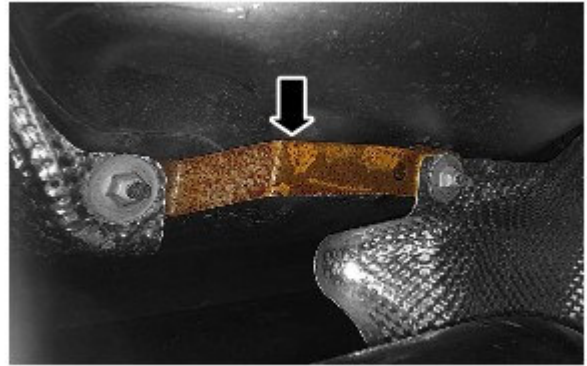
E181029

3. Inspect the fuel tank shield bracket for corrosion.

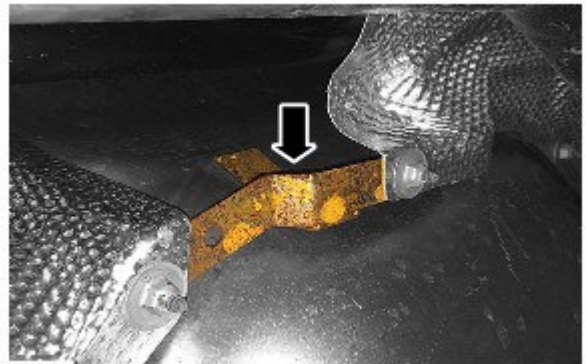
E181030

4. Inspect the fuel tank shield bracket for corrosion.

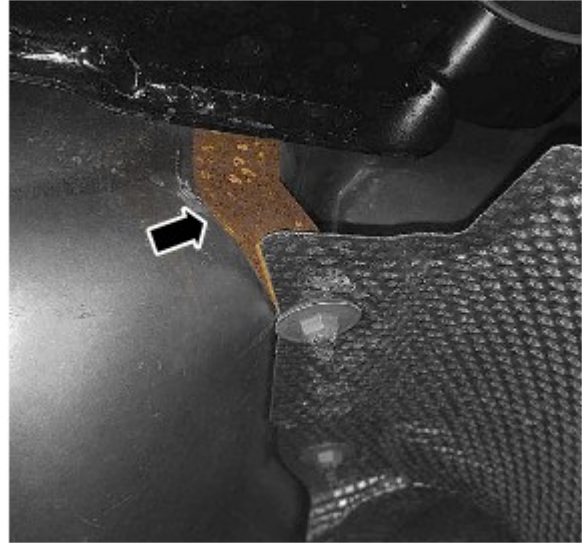
E181031

5. Inspect the fuel tank shield bracket for corrosion.
