Subject: RUST ON UNDERCARRIAGE	Bulletin No: 00-004/15
	Last Issued: 11/17/2015

2015 Mazda3 (Mexico built) vehicles with VINs starting with 3MZ (see attached VIN list)

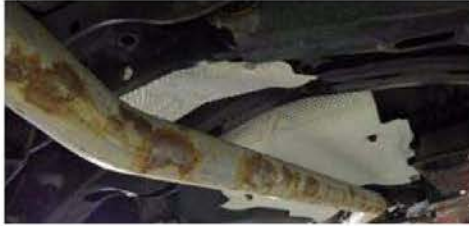
Before

Some vehicles that were held in Port Veracruz may exhibit surface rust on the undercarriage. Port Veracruz is at the southern part of Mexico, facing the Gulf of Mexico. This area is known for very harsh environmental conditions such as extremely hot conditions, acid rain, strong winds and heavy rainfall. The combination of these natural elements can result in surface rust to the exterior chrome moldings and metal undercarriage components.

1. Verify customer concern and confirm that customer's vehicle is on the attached VIN list.
2. Raise vehicle completely in air to clean and seal undercarriage
3. Using a semi-rough scrub pad, remove any surface rust/rust from the entire (top, bottom and sides) exhaust system. Wipe the exhaust with clean paper towel. If the vehicle is equipped with chrome exhaust tip(s), use a soft/fine scrub pad and remove the rust from them. Using the same pad, clean any rust from inside the exhaust tip. Using a large wire brush, clean the flange between the rear silencer and the front exhaust pipe.

NOTE: DO NOT use Rust Fix on the exhaust system.
