Subject: WHINING NOISE FROM AUTOMATIC TRANSAXLE	Bulletin No: 05-005/15
	Last Issued: 11/17/2015

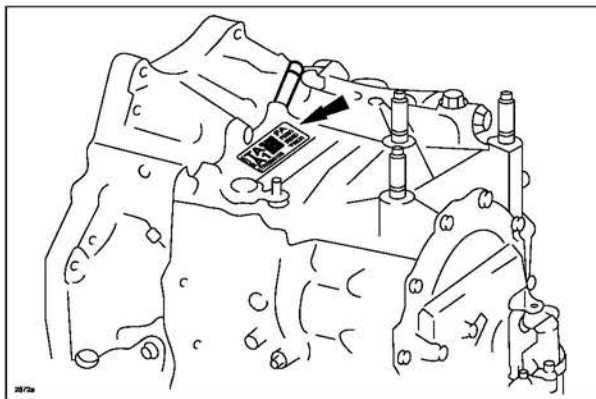
This is caused by a damaged bearing in the transaxle due to improper configuration of the transaxle case. A modification has now been implemented on automatic transaxles with the serial number 3TR1111680 and higher or 3TD1104906 and higher. The serial number can be found on top of the transaxle case near the manual shaft lever.
