Subject: AIR TEMPERATURE WILL NOT CHANGE	Bulletin No: 07-003/15
	Last Issued: 11/17/2015

2014-15 Mazda3 (Japan built with manual A/C) with VINS lower than JM1BM*****247593 (produced before December 1, 2014)

2014-15 Mazda3 (Mexico built with manual A/C) with VINS lower than 3MZBM*****182009 (produced before January 1, 2015)

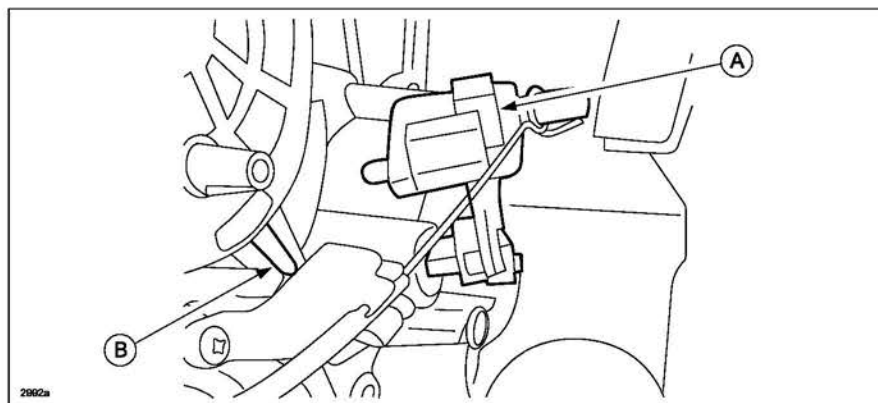
Some customers may complain that the air temperature from the air conditioner will not change with the air temperature control knob, and may be accompanied by some rattle noise from behind the dash board. This concern may be caused by the temperature control link being pulled out of the HVAC housing. To correct the problem, the temperature control link has been modified.

1. Verify customer concern.
2. Refer to the instructions on MS3 online or the Workshop Manual (section 07-40 CLIMATE CONTROL UNIT REMOVAL/INSTALLATION [MANUAL AIR CONDITIONER]) and check that the MIX LINK (Air mix link/Temperature control link) (A) is properly connected to the MIX DOOR CRANK (B) and works while rotating the temperature control knob.
