<b>Subject:</b>  SQUEAKING/GRINDING NOISE FROM REAR BRAKE	<b>Bulletin No:</b> 04-003/15
	<b>Last Issued:</b> 11/06/2015

2014-16 Mazda3 vehicles with VINs starting with JM1

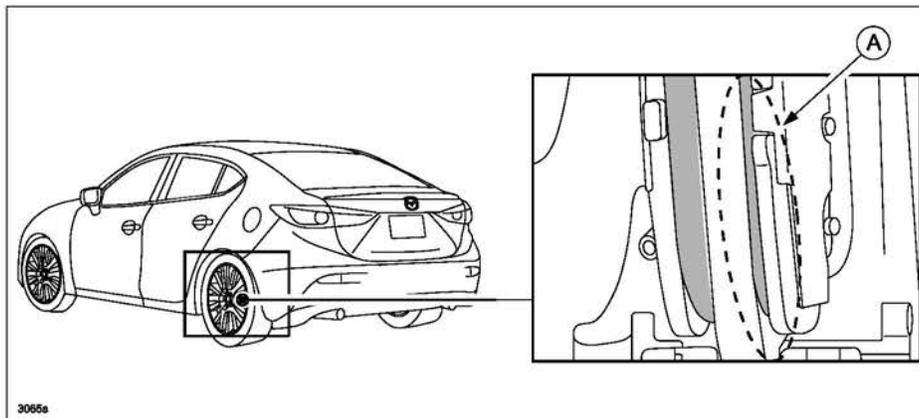
Some vehicles may experience a squeaking/grinding noise from the rear brake even after the brake pedal is released. Upon inspection, the caliper mounting support is corroded and the disc pad is abnormally worn out (A). This is caused by vehicle usage in an area using road salt. The surface of the mounting support may swell from corrosion causing premature disc pad wear and brake noise.

To correct the problem, an improved caliper mounting support has been newly established as a service part. The anti-corrosion surface treatment has been changed from Zn to Zn-Ni plating.

1. Verify that the caliper mounting support(s) is corroded and the disc pad(s) is abnormally worn out.
2. Replace the caliper mounting supports (both sides) with the modified service parts sets and attachments with new parts according to the instructions on MS3 online or the Workshop Manual (section 04-11 REAR BRAKE (DISC) REMOVAL/INSTALLATION).

**NOTE:** Replace the disc plate(s) additionally if damaged by the completely worn out disc pad.
