Subject: TPMS WARNING LIGHT ON	Bulletin No: 02-002/15
	Last Issued: 11/03/2015

BULLETIN NOTE

2014-2015 Mazda6 vehicles (except Canada and Mexico) with VINs between JM1 GJ1 ***** 224859-225009 (produced between November 27, 2014 - December 01, 2014)

2016 Mazda6 vehicles with VINs between JM1 GJ1 ***** 400011-412885 (produced between November 24, 2014 - February 11, 2015)

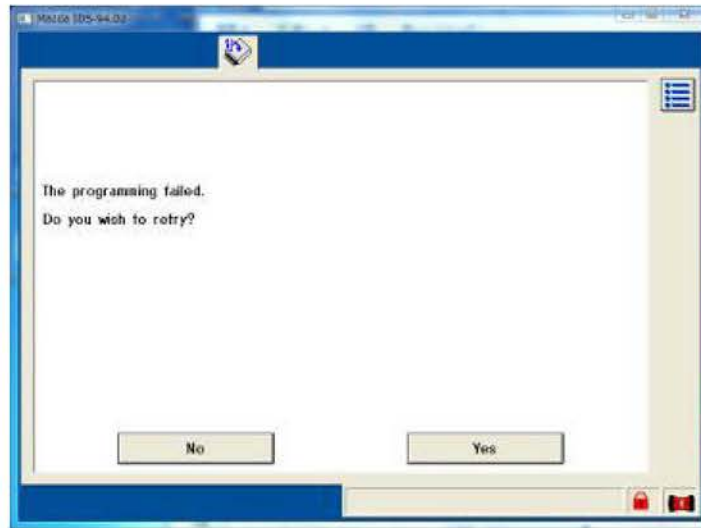
- a. If the screen shows “The programming failed. Do you wish to retry?” with Yes/No buttons, DO NOT Click the buttons and proceed to “**Recovery**” below.

Recovery

- a. Turn IG off. (If needed, press and hold the start button.)
- b. Remove the ABS/DSC 30A fuse for 10 seconds.
- c. Install the fuse and turn IG ON.
- d. Click "Yes" button and follow the on-screen instruction.

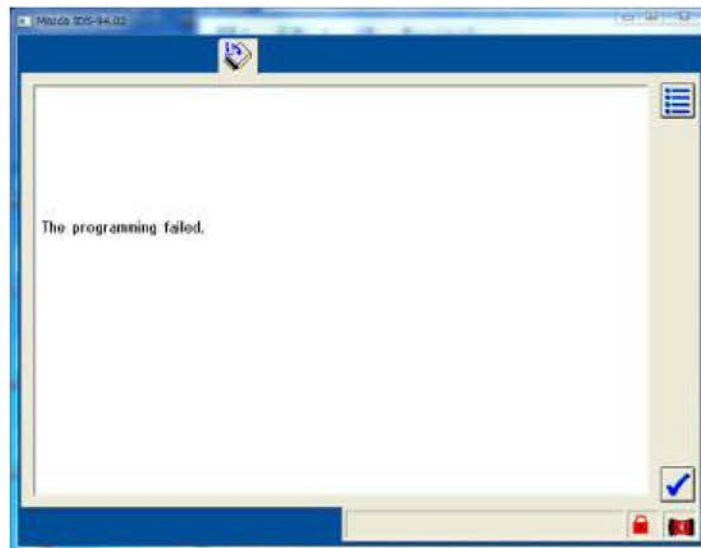
- b. If the screen shows “The programming failed.” without Yes/No buttons, the ABS module has to be replaced with new one.
