Subject: RATTLE NOISE FROM HEADER PANEL OF CONVERTIBLE TOP	Bulletin No: 09-045/15
	Last Issued: 12/23/2015

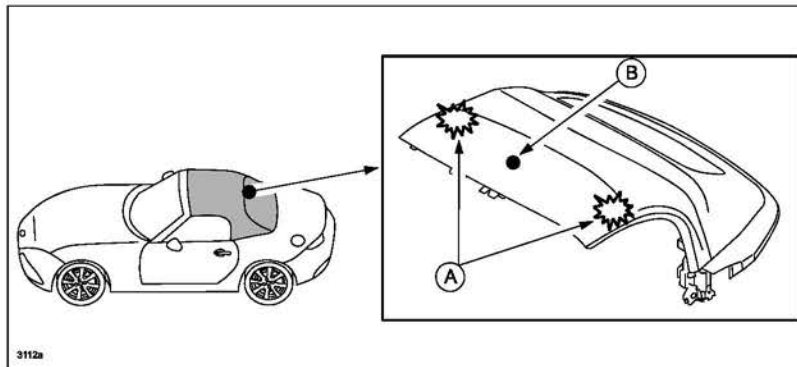
Some vehicles may exhibit a rattle noise (A) from the header panel (B) of the convertible top when driving on a rough road.

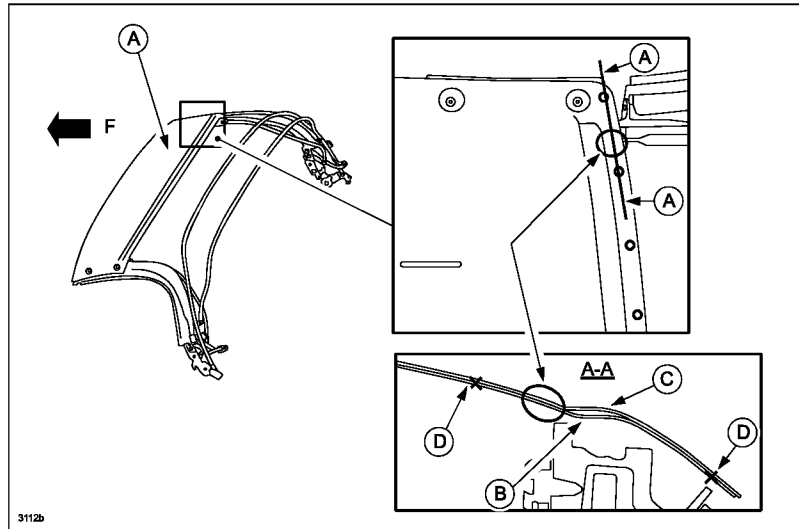
The header panel (A) is formed by two aluminum panels, inner (B) and outer (C). When receiving an input force by driving on a rough road, the two panels at the problem area, where spot welds are located (D), may warp and change relative position causing the rattling noise. (F=Front)
