# Service Bulletin

Subject: Bulletin No: 05-007/15

IGNITION DOES NOT TURN OFF WHEN PRESSING START / STOP BUTTON

### APPLICABLE MODEL(S)/VINS

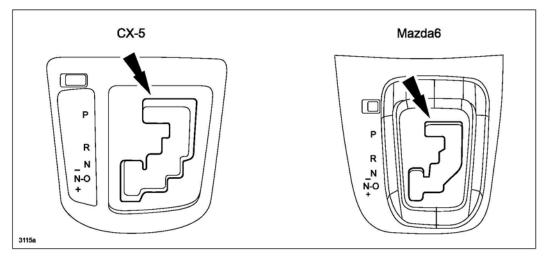
When pressing the START/STOP button, the ignition may not turn off on some vehicles equipped with a gatetype AT shifter. Although the shift lever is in "P" position and the engine shuts off normally, the ignition may stay on (in accessory mode).

This concern may be caused by a worn switch unit. To eliminate this concern, the switch unit material has been changed to improve wear resistance. Modified switch units have been established as new service parts.

Customers having this concern should have their vehicle repaired using the following repair procedure.
