Service Bulletin

Subject: Bulletin No: 09-046/15

WHITE DOOR ARMREST(S) PINK DISCOLORATION

2014-2016 Mazda6 vehicles with VINs lower than JM1 GJ ***** 458701 (produced before November 09, 2015)

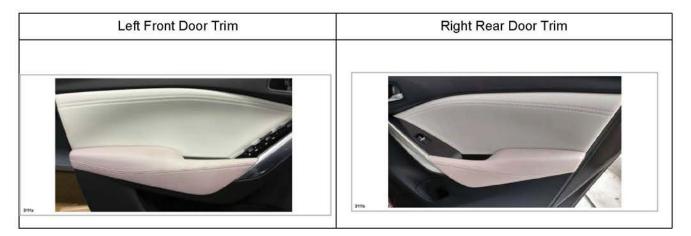
Some customers may complain about a white door armrest(s) pink discoloration. The discolored armrest does not match the other white parts of the door panel.

- 1. Verify customer concern.
- 2. Replace all 4 door panels. Refer to MS3 online or Workshop Manual section 09-17:
 - FRONT DOOR TRIM REMOVAL/INSTALLATION
 - REAR DOOR TRIM REMOVAL/INSTALLATION
- 3. Verify repair.
