Subject: SQUEAK NOISE FROM WINDSHIELD WIPER LINK	Bulletin No: 09-010/15
	Last Issued: 12/18/2015

2014-15 Mazda3 vehicles with VINs lower than JM1BM*****227327 (produced before August 1, 2014)

2014-15 Mazda3 vehicles with VINs lower than 3MZBM*****194031 (produced before February 11, 2015)

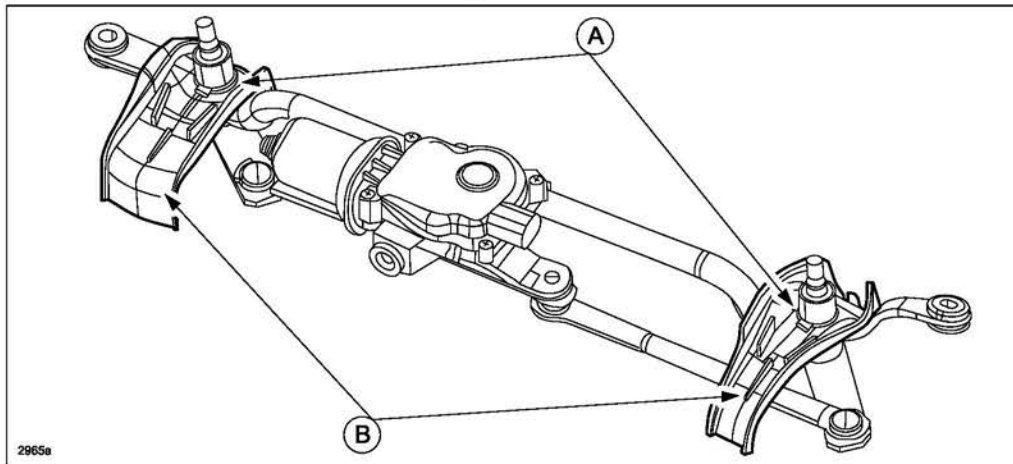
Some vehicles may exhibit a squeaking noise from the windshield wiper link when operating the wipers. This noise may be caused by rust on the sliding parts from water entry through the pivot (A). To prevent water entry, the pivot cover (B) has been enlarged and an O-ring has been added to the pivot.

1. Verify customer concern.
2. If noise occurs when operating the wipers, replace the windshield wiper link assembly with a modified one. Refer to the instructions on MS3 online or the Workshop Manual (section 09-10 WINDSHIELD WIPER MOTOR AND LINK REMOVAL/INSTALLATION).
3. Verify repair.
