Subject: NOISE FROM FUEL TANK INSULATOR	Bulletin No: 01-010/15
	Last Issued: 12/14/2015

2010-2015 CX-9 vehicles with VINs lower than JM3TB*****460027 (produced before April 1, 2015)

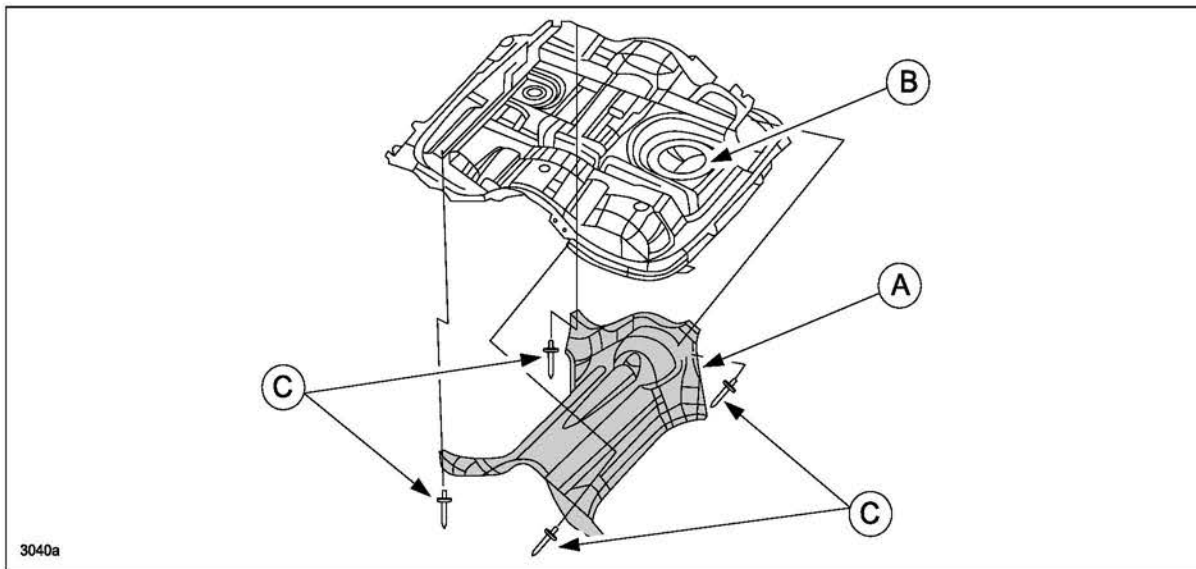
Some vehicles may exhibit an unusual noise while driving the vehicle. The noise may be caused by a broken fuel tank (B) insulator (A) that is hanging down and contacting the propeller shaft.

The rivets (C) may break when a load occurs. The rivet material has been changed to eliminate this concern. Customers having this concern should have their vehicle repaired using the following repair procedure.

1. Verify the customer concern.
2. Safely raise the vehicle on a hoist, then inspect the insulator for damaged at the rivet(s).
3. Remove the pre-silencer from the vehicle according to the instructions on MS3 online or the Workshop Manual (section 01-15 EXHAUST SYSTEM REMOVAL/INSTALLATION [MZI-3.7]).

4. Remove and discard the insulator from the fuel tank.

CAUTION: When removing the rivet pins using a drill, pay close attention not to damage the fuel tank.

5. Install the new insulator with modified rivets.
