<b>Subject:</b>  REAR CONSOLE LID IS LOOSE	<b>Bulletin No:</b> 09-023/15
	<b>Last Issued:</b> 12/14/2015

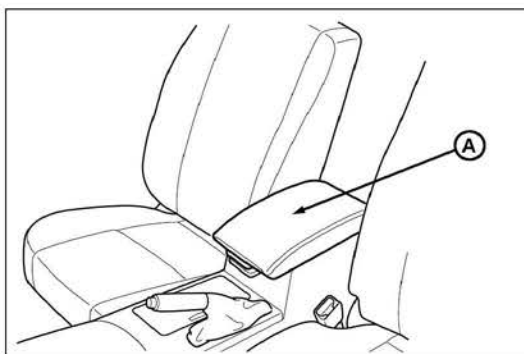
Some customers may complain about a loose rear console lid (A).

Customers having this concern should have their vehicle repaired using the following repair procedure.

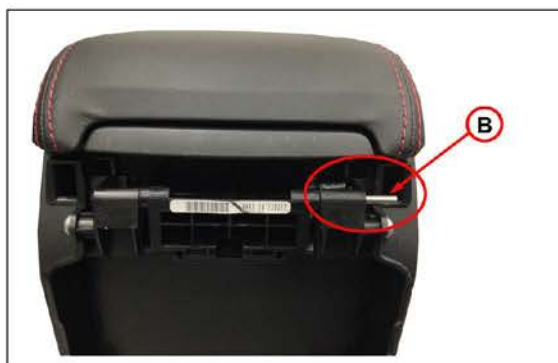
This may be caused by hinge pins coming partially off (B) or completely off.

**NOTE:** The shape of the rear console panel has been changed, by adding a stopper rib to prevent the pin from coming off.

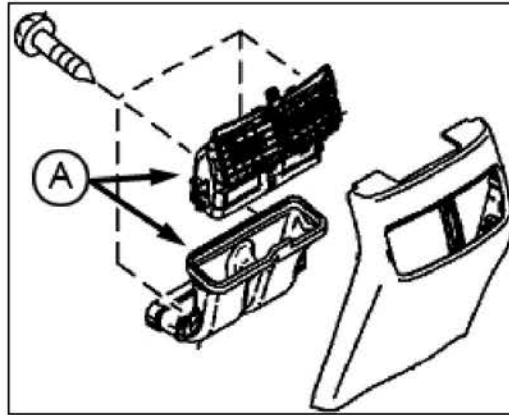
**NOTE:** The shape of the rear console panel has been changed, by adding a stopper rib to prevent the pin from coming off.

5. Mazda6 with ventilation, install a new rear console panel (see PART(S) INFORMATION) and reuse the rear and front ducts (A).
