<b>Subject:</b> RATTLE NOISE FROM HEADER PANEL OF CONVERTIBLE TOP	<b>Bulletin No:</b> 09-045/15
	<b>Last Issued:</b> 12/04/2015

2016 MX-5 vehicles with VINs lower than JM1ND\*\*\*\*\*107384 (produced before October 26, 2015)

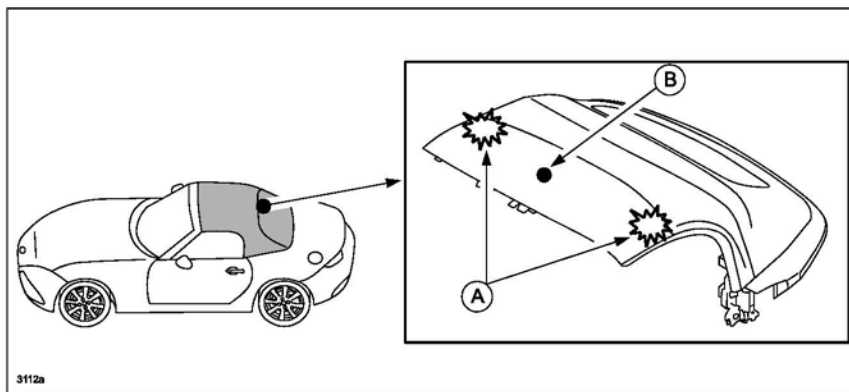
Some vehicles may exhibit a rattle noise (A) from the header panel (B) of the convertible top when driving on a rough road.

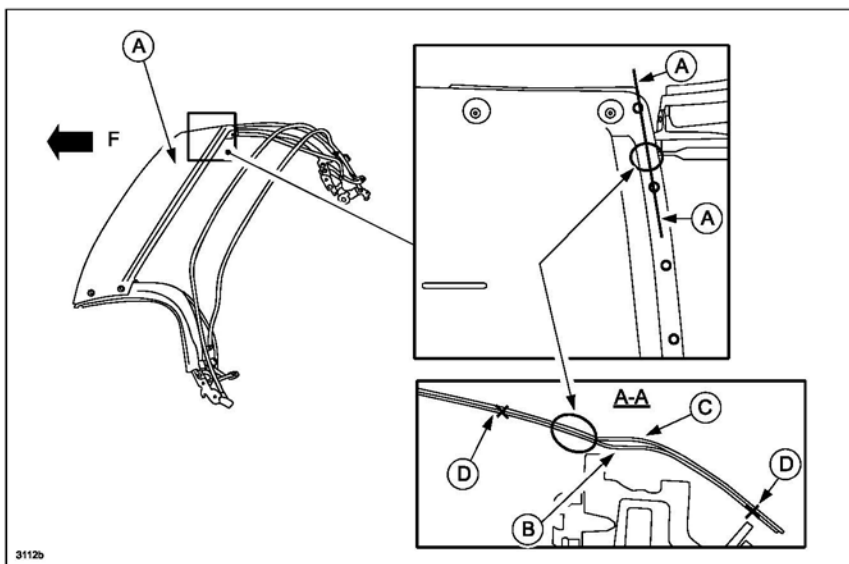
The header panel (A) is formed by two aluminum panels, inner (B) and outer (C). When receiving an input force by driving on a rough road, the two panels at the problem area, where spot welds are located (D), may warp and change relative position causing the rattling noise. (F=Front)
