<b>Subject:</b> BSM OFF INDICATOR ON WITH DTC U1A4B:97 OR U3000:97	<b>Bulletin No:</b> 15-002/15
	<b>Last Issued:</b> 12/10/2015

2016 MX-5 vehicles with VINs lower than JM1ND\*\*\*\*\*104338 (produced before August 20, 2015)

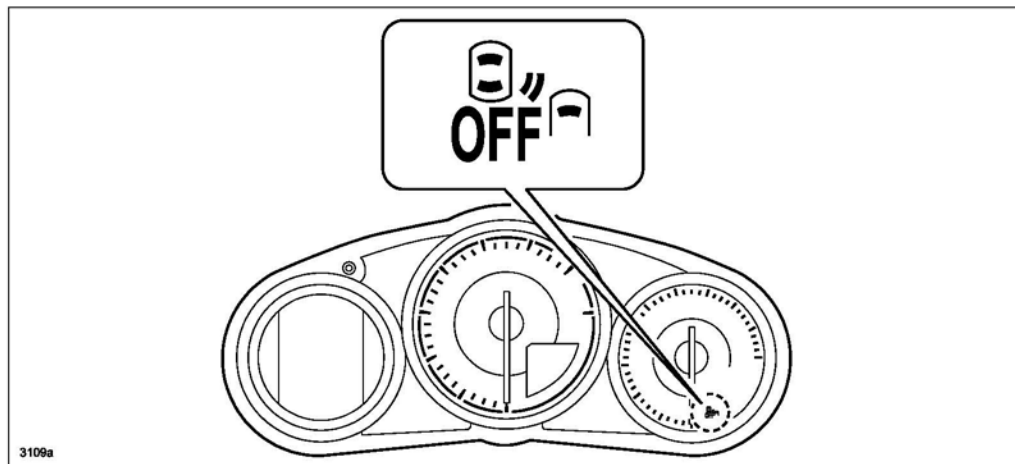
- The BSM turns "OFF" and the BSM OFF indicator turns "ON" in the instrument cluster while driving
- The BSM will not turn on again during the drive cycle
- After cycling the ignition switch off and on again, the BSM operates normally
- DTC U1A4B:97 or U3000:97 is stored in memory
  - DTC U1A4B:97 - Radar sensor sensitivity temporarily decreases depending on various external and environmental factors (blind spot monitoring (BSM) control module (RH))
  - DTC U3000:97 - Radar sensor sensitivity temporarily decreases depending on various external and environmental factors (blind spot monitoring (BSM) control module (LH))

To correct this problem, the control logic of the BSM control modules has been changed.

1. Verify customer concern.
2. Replace both the BSM control modules with modified ones according to the instructions on MS3 online or the Workshop Manual (section 09-10 BLIND SPOT MONITORING (BSM) CONTROL MODULE REMOVAL/INSTALLATION).
