# Service Bulletin

Subject:	Bulletin No:	04-005/15
2013-2014 CX-5 - SQUEAKING / GRINDING NOISE FROM REAR BRAKES		
	Last Issued:	12/04/2015

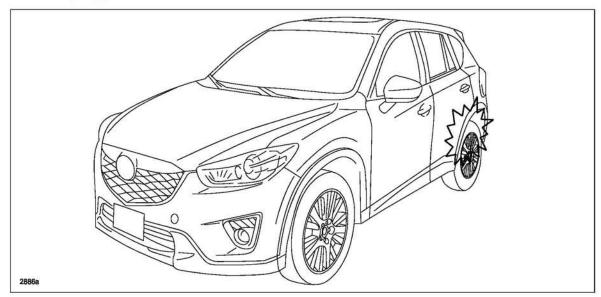
Some vehicles may exhibit a squeaking / grinding noise from the rear brakes. This noise may be caused by the wear indicators of prematurely worn **outer** rear brake pads.

NOTE: The inner rear brake pads will only show a little wear. This condition only affects the outer rear brake pad(s).

During usage of the vehicle in areas where road salt is used, the **outer** rear brake pad(s) may become stuck due to corrosion. This may cause brake dragging and premature wear to the **outer brake pad(s) only**.

The treatment of the brake pad back plate has been changed to eliminate this concern.
